LABORATORY TEST REPORT

LTR 6158-2470

EVALUATION OF VERICODE
LASER MARKED MATERIALS

Rockwell International
Space Systems Division

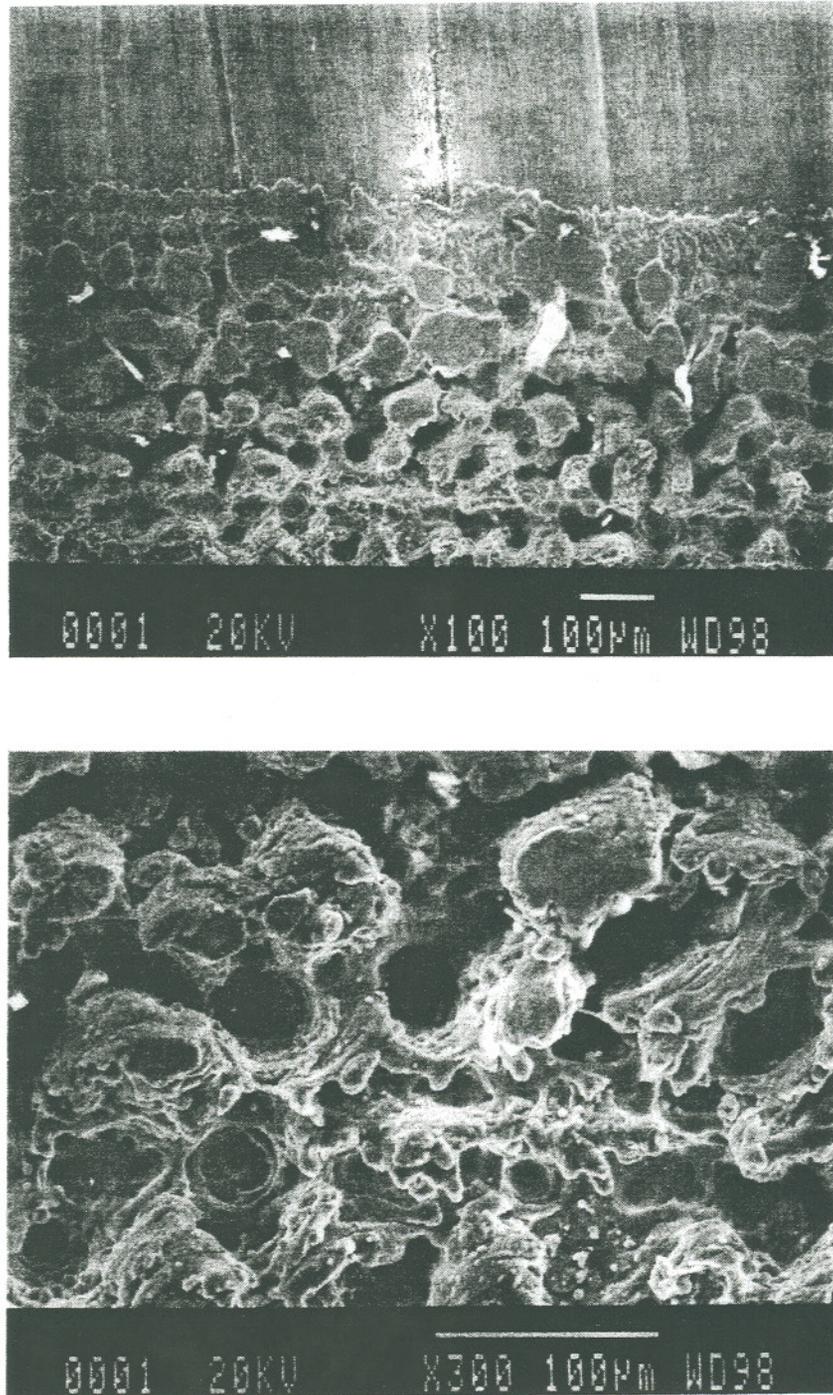
In general, the aluminum materials exhibited a molten and resolidified surface modification readily discernible from the substrate control surface. While the resolidification patterns were distinct, there was no evidence of any cracking, either substantial or superficial, related to the laser marking. Refer to Figures 2 through 5 for typical examples of the surface modification.

Figure 2. *2024 Aluminum (100X & 300X)*
Illustration of the effects of laser marking on the aluminum substrate. Note the distinct re-cast surface layer and roughness. No substrate cracking is apparent.

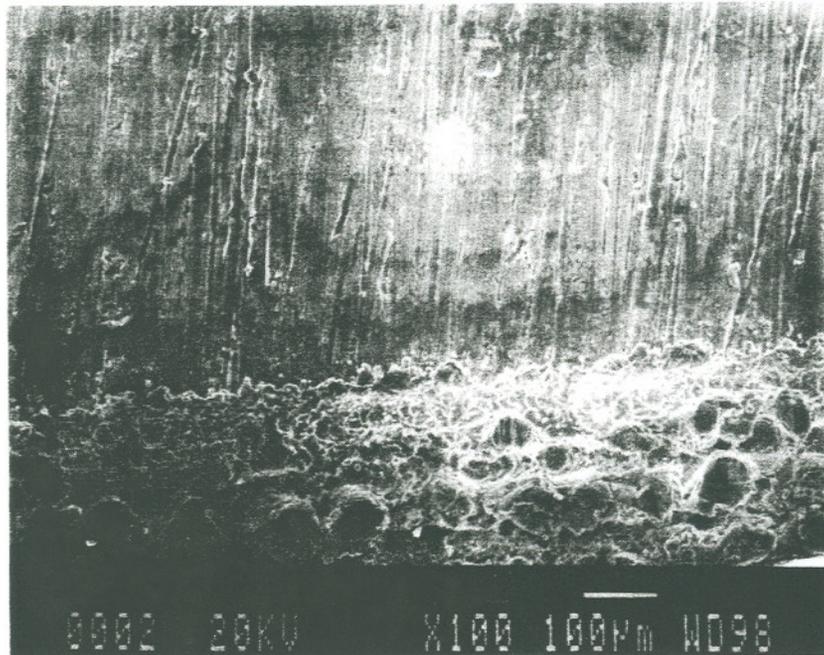
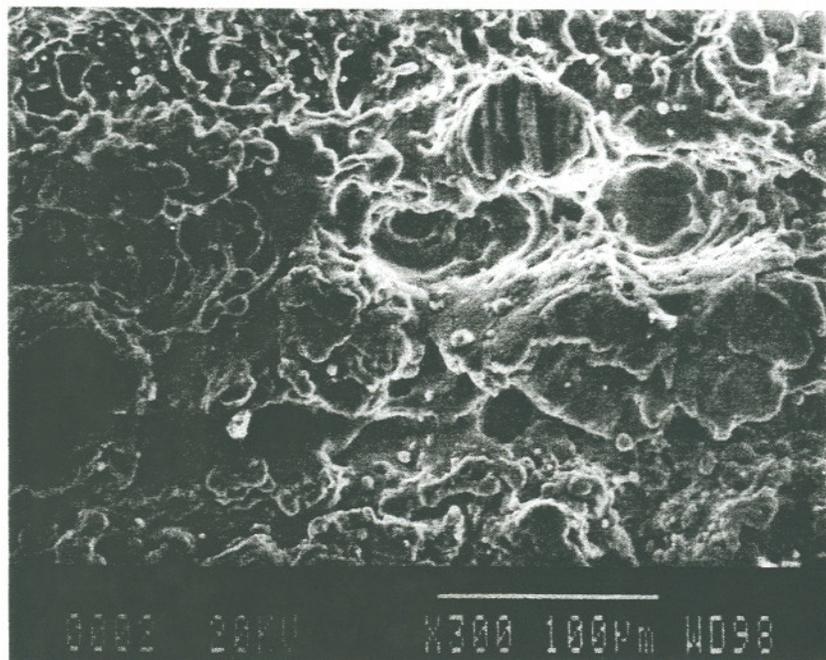
Figure 3. 6061-T6 Aluminum (100X & 300X)
Note the re-cast surface layer and associated roughness. No evidence of substrate cracking can be seen.

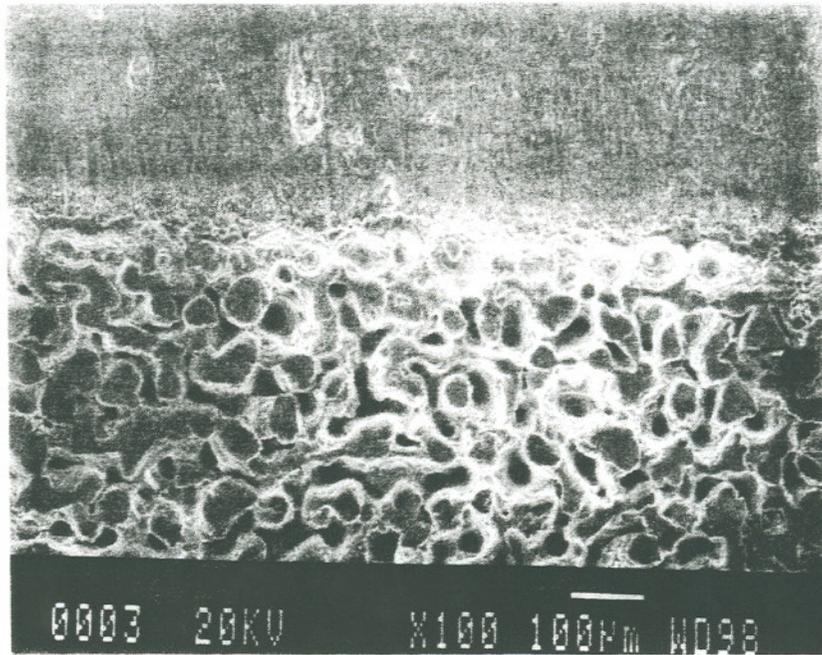
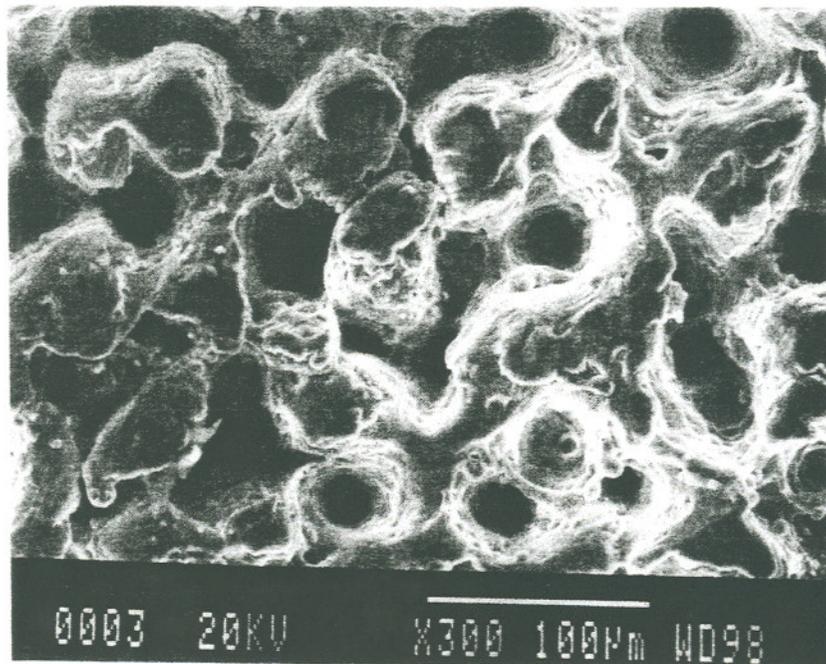
Figure 4. 7075 Aluminum (100X & 300X)
Significant surface roughness from melting and re-cast of the surface layer are evident, but no cracking is visible.

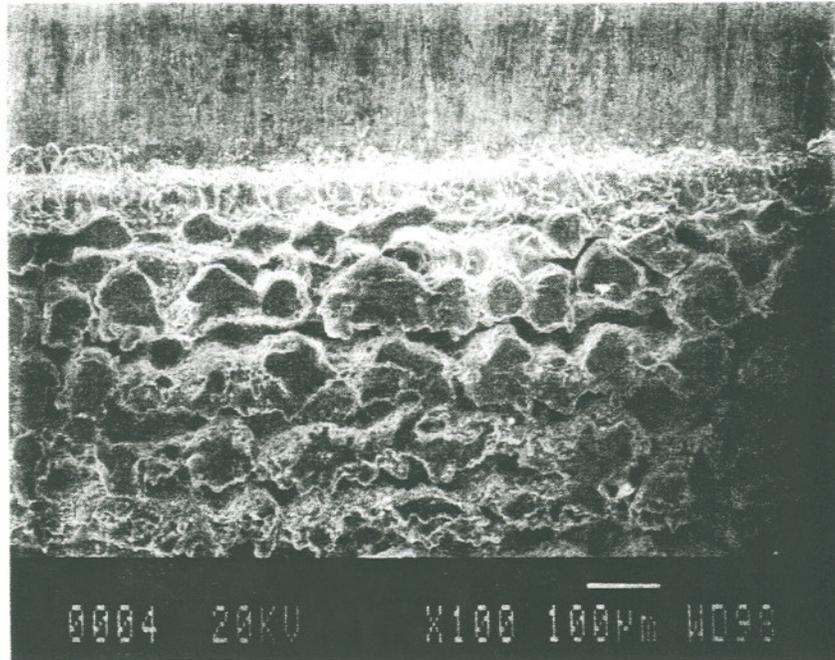
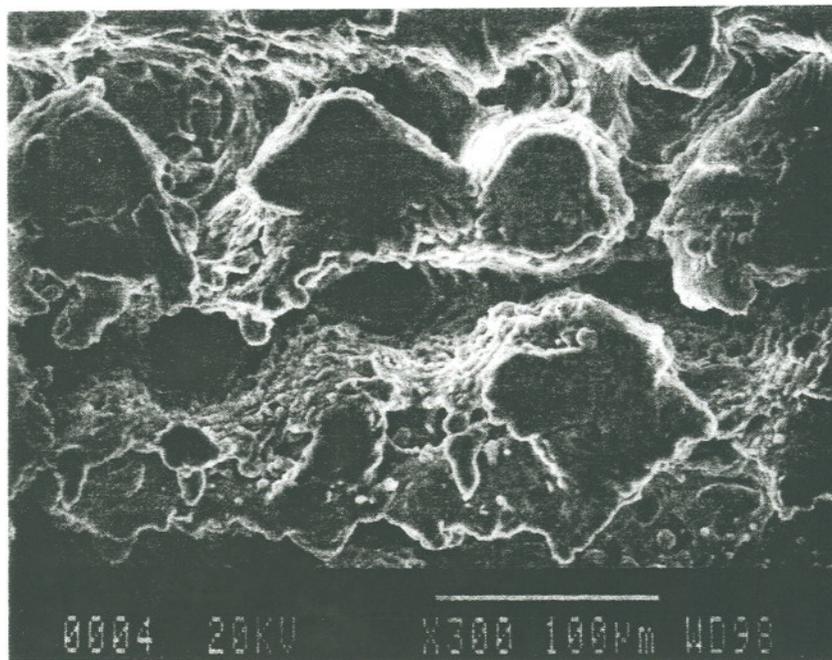
Figure 5. 356.2 Aluminum Casting (100X & 300X)
Substantial surface re-cast has resulted in significant surface roughness, but no substrate cracking is evident.

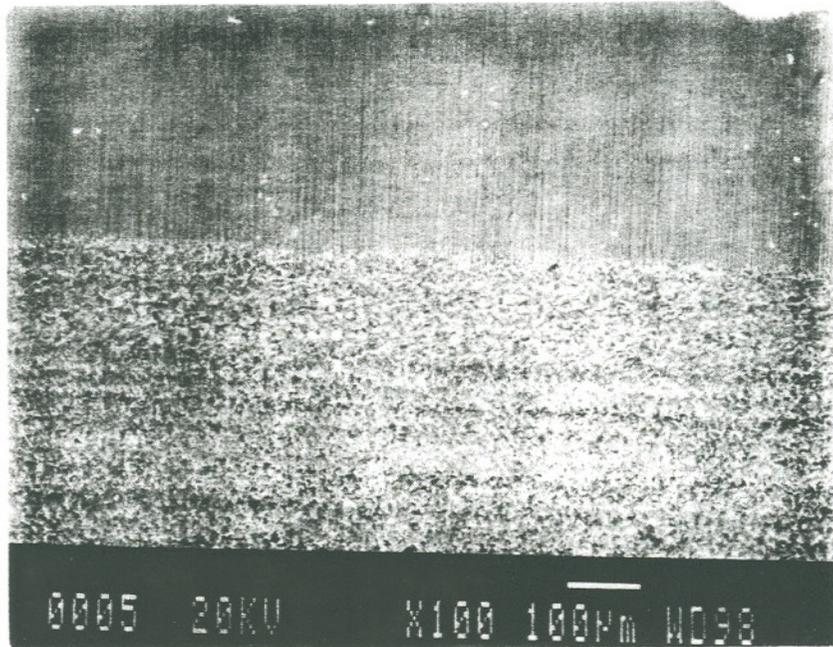
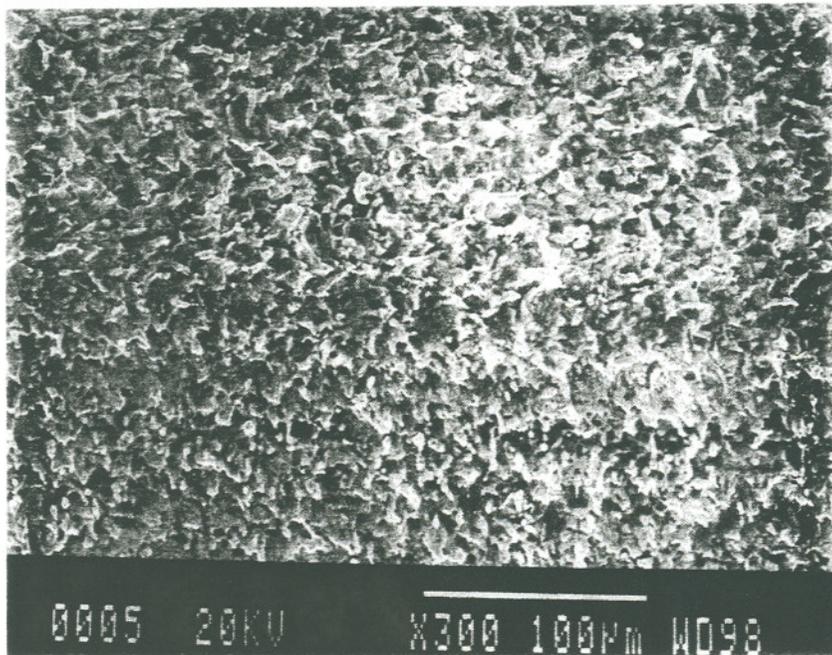
The CDA copper specimen exhibited a fine structured recast layer, apparently significantly more shallow than observed on the aluminum specimens. No cracking, either superficial or deep was noted on the laser marked surface. Refer to Figure 6.

Figure 6. CDA 101 Copper (100X & 300X)
The readily visible surface re-cast layer is fine in texture, but exhibits no apparent substrate cracking. The texture is also very uniform.

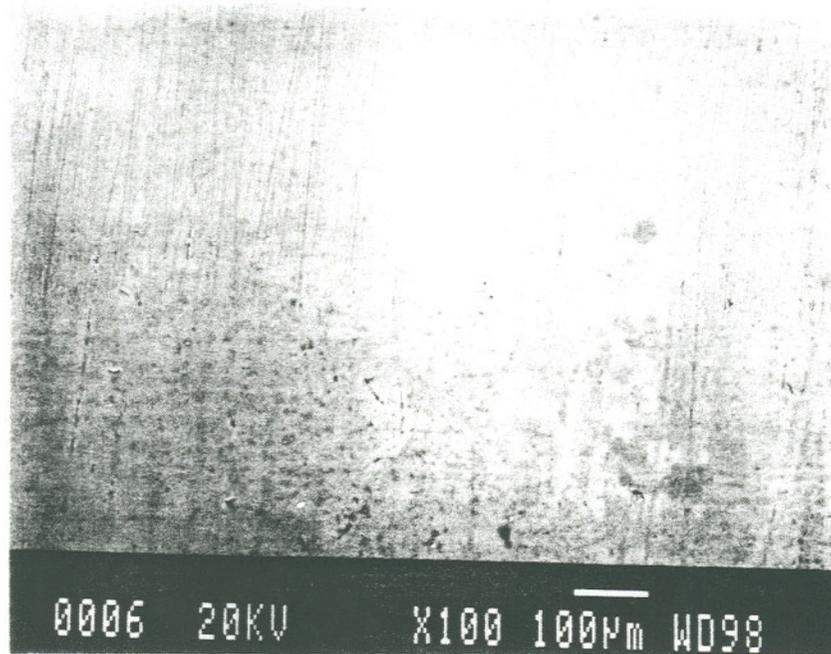
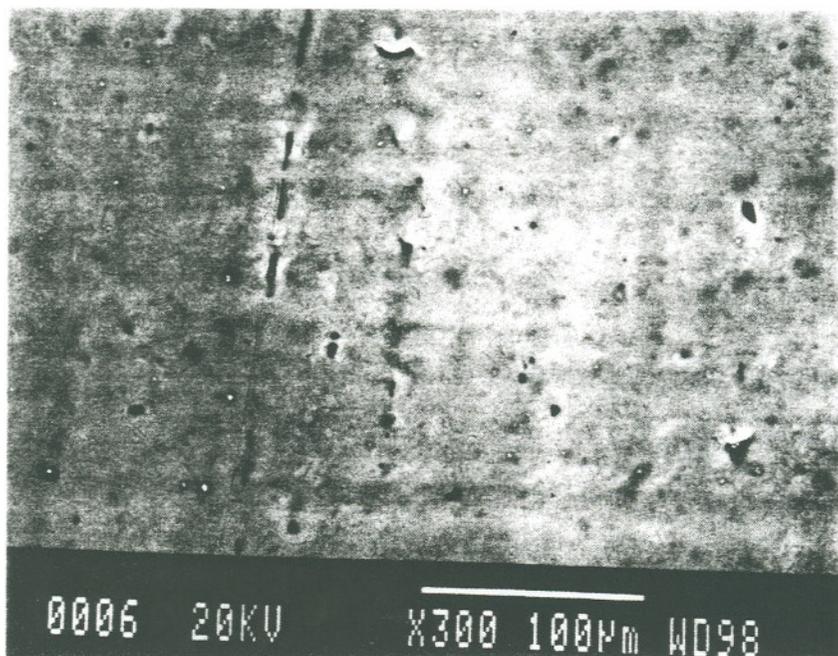
Figure 7. C1020 Steel (100X & 300X)
The laser marked surface region exhibits a smooth, undulating surface texture suggesting a very shallow re-cast depth. No indication of substrate cracking is apparent.

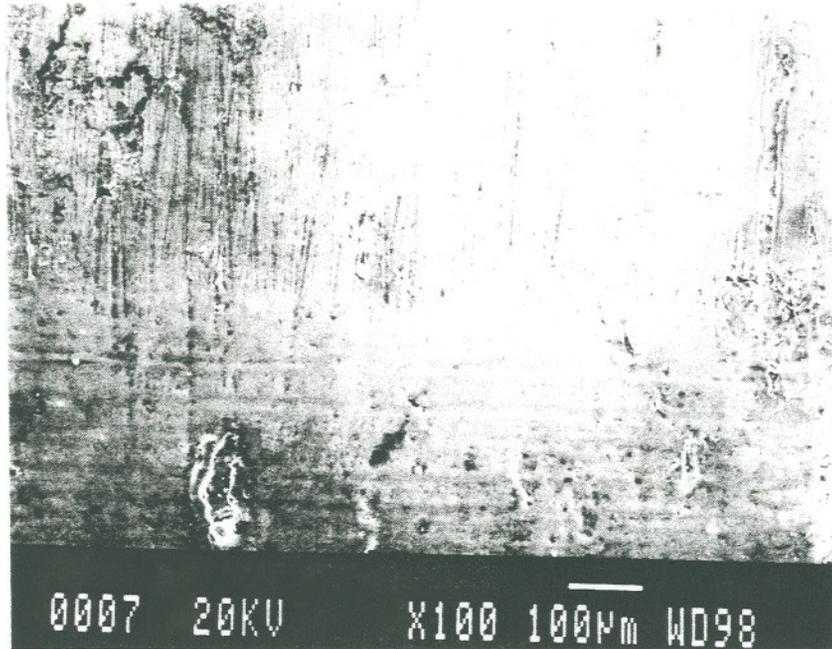
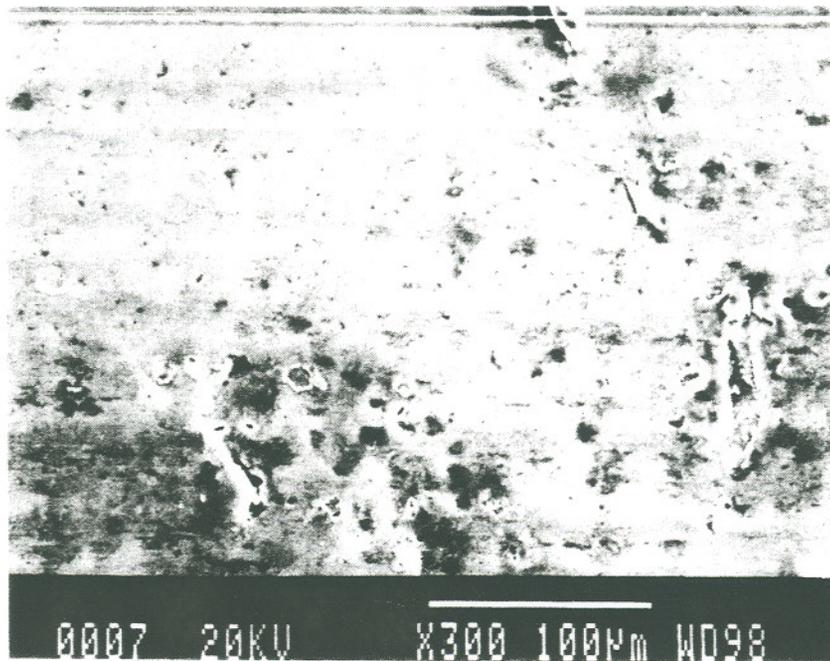
Figure 8. C4130 Steel (100X & 300X)
The surface texture in the marked region is similar to that of the C4130 steel, but does exhibit slightly more surface distress. No cracking was apparent.

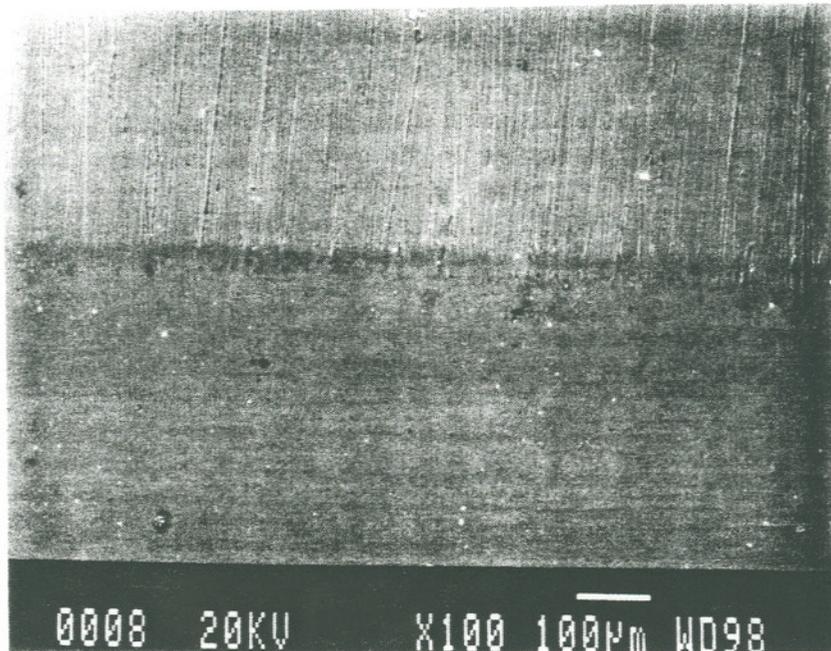
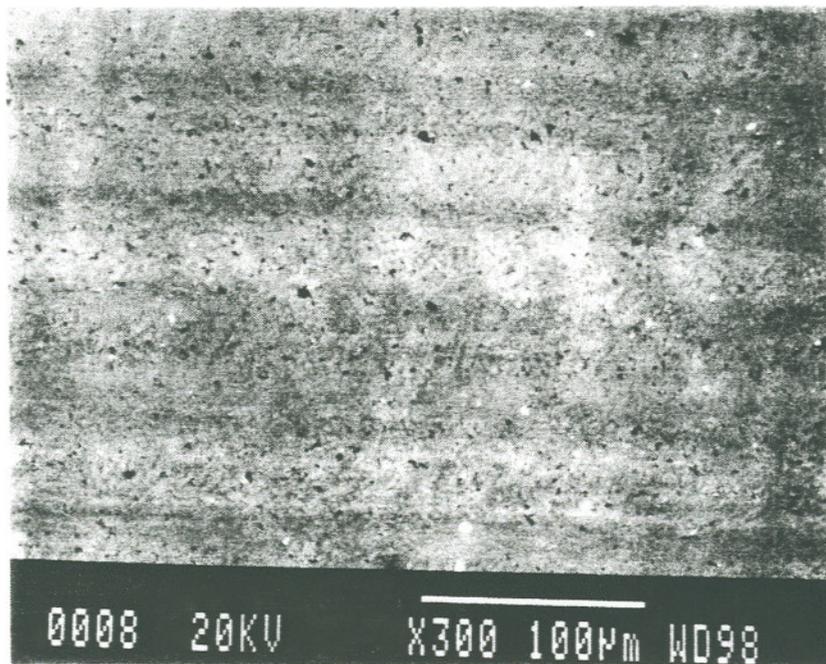
Figure 9. *17-4PH Steel* (100X & 300X)
As with most of the steels, the affected region appears to be very shallow. While the surface is generally smooth, it is slightly 'pock-marked', but without cracking.

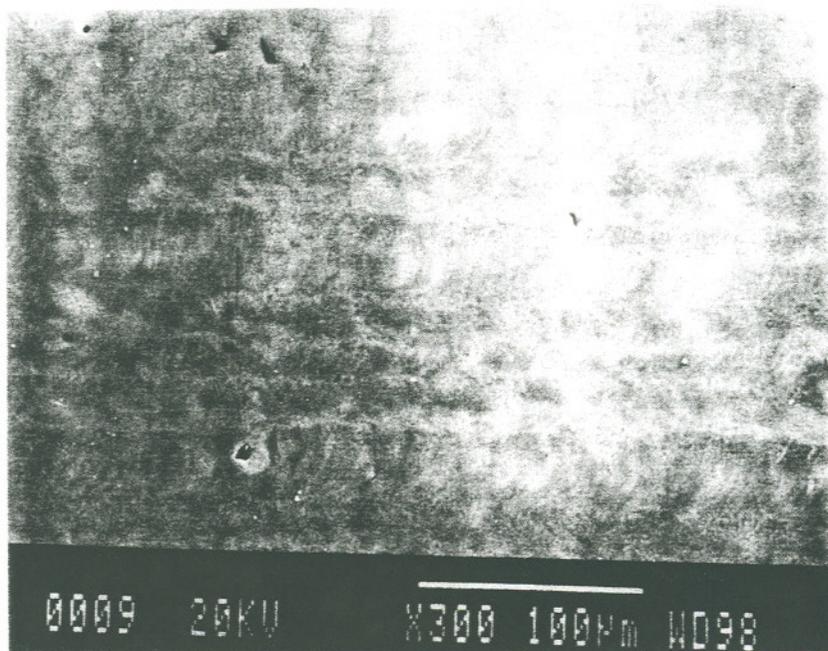
Figure 10. 316 CRES (100X & 300X)
The surface of the marked area was very smooth, exhibiting the fine periodic structure of the laser pulsing. No substrate cracking was observed.

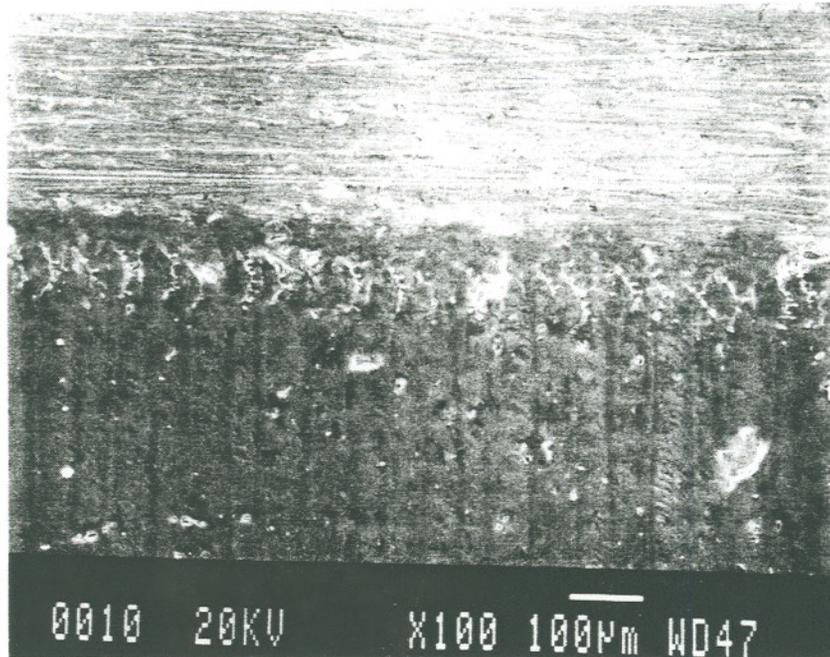
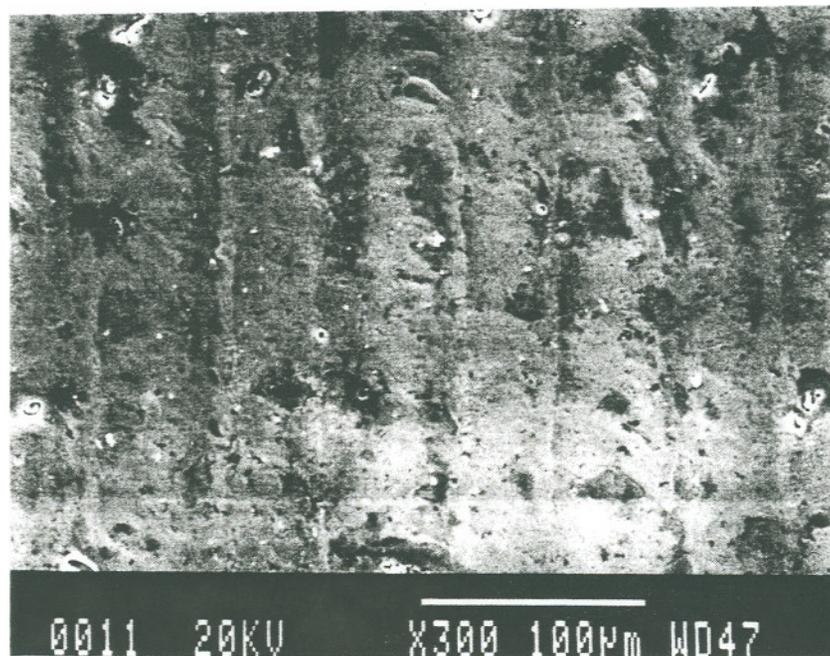
Figure 11. 446 CRES (100X & 300X)
The surface of the marked area was generally smooth, but with some indication of the path of the laser travel over the specimen surface. Again, no cracking was noted.

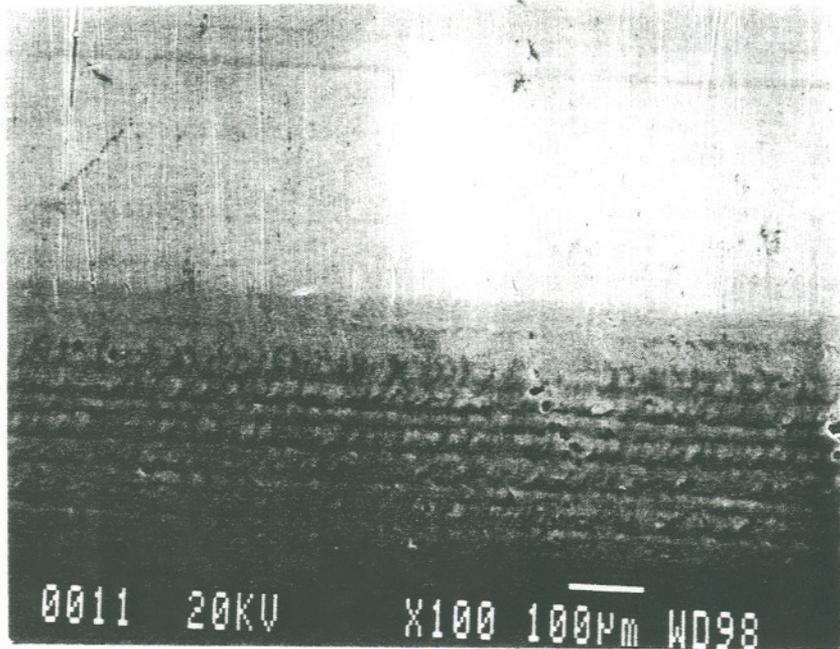
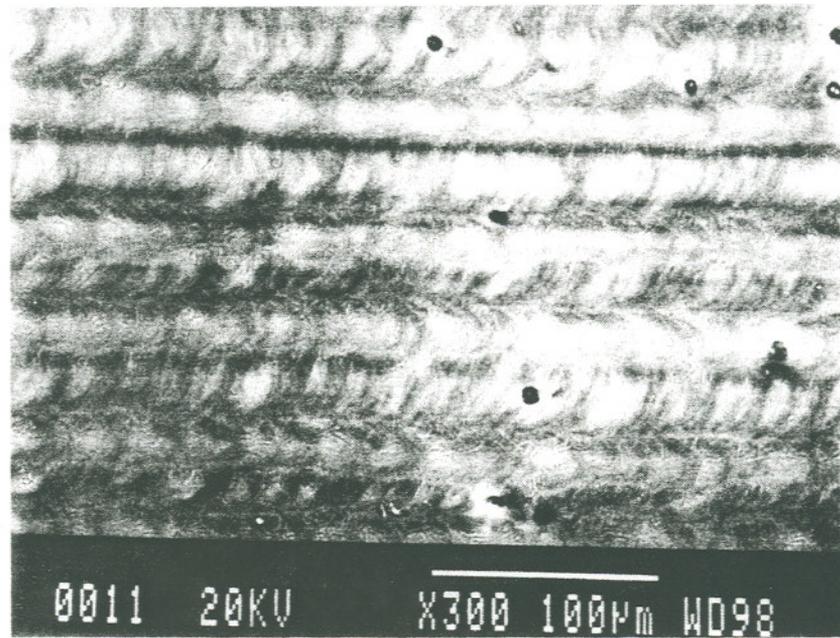
Figure 12. A286 CRES (100X & 300X)
The marked surface was readily apparent, although the depth of the re-cast layer appeared to be moderate to shallow. No cracking was noted.

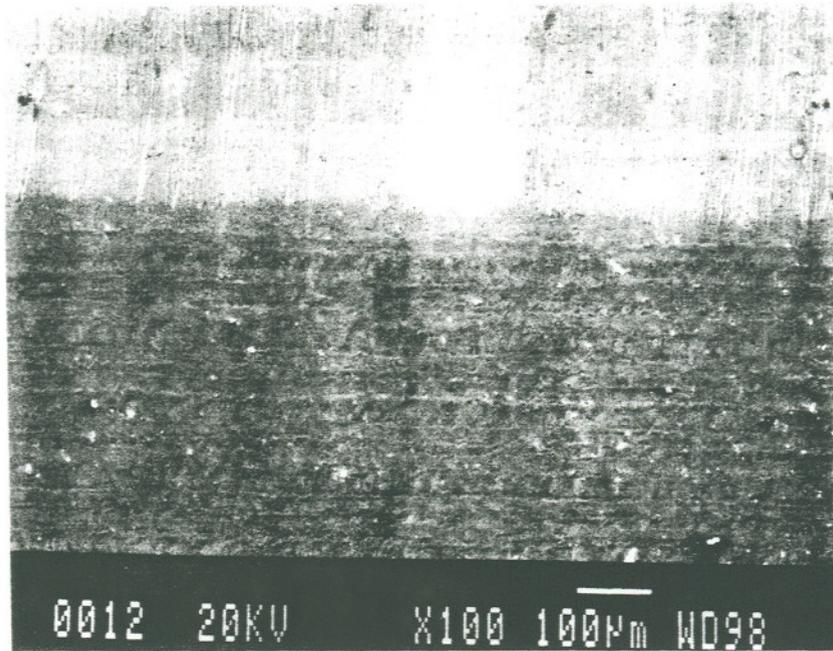
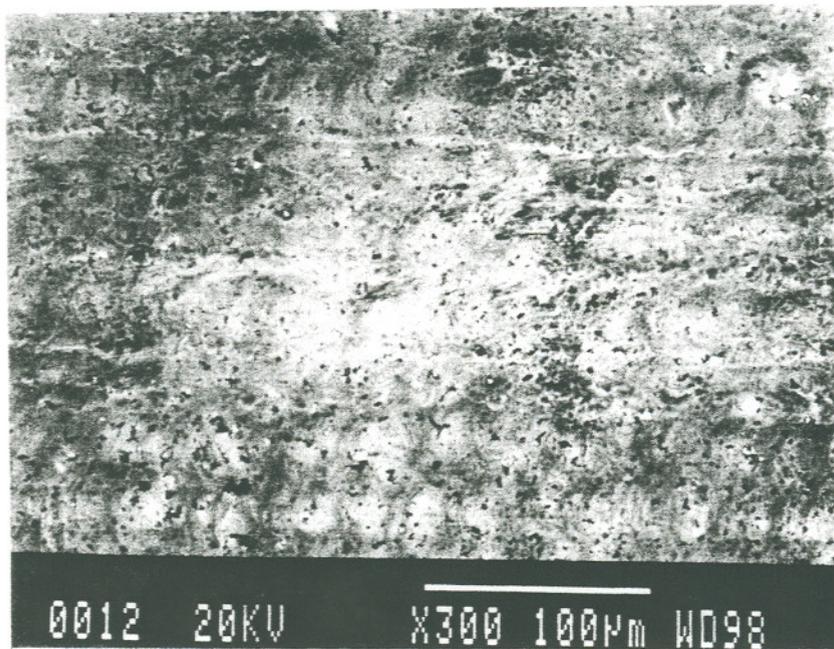
Figure 13. *Inconel 625* (100X & 300X)
The marked area was generally smooth in texture, with small 'pock-marks'. No cracking was observed.

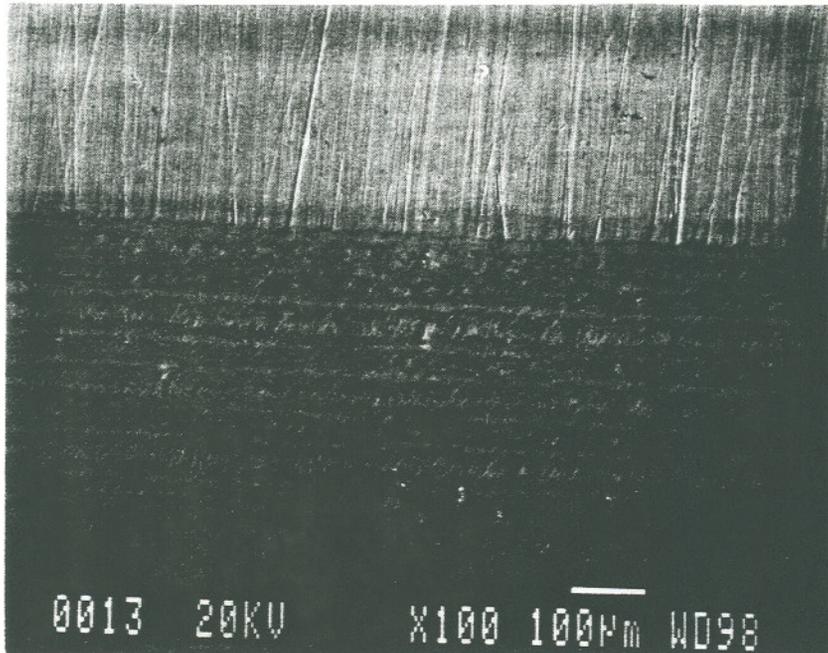
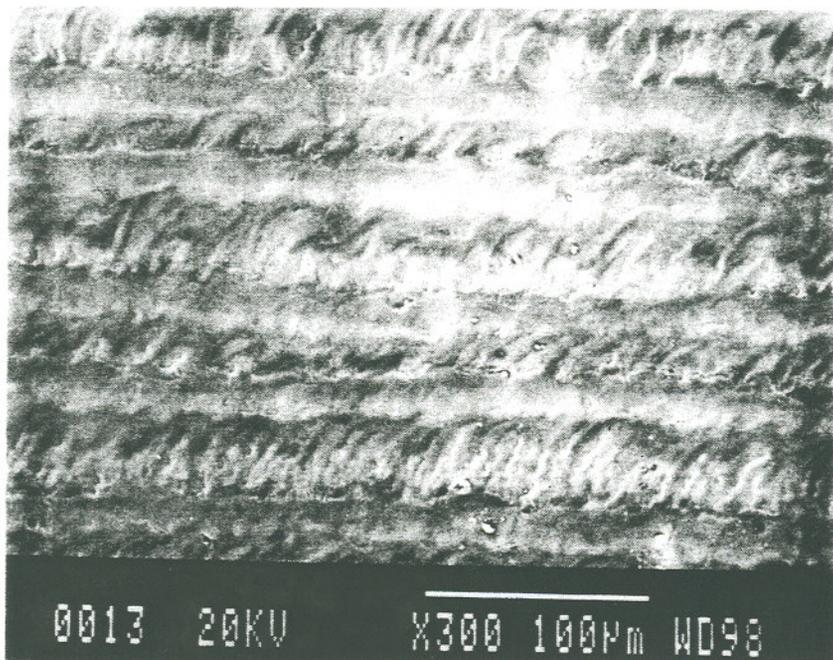
Figure 14. *Inconel 718* (100X & 300X)
The path of laser travel was readily apparent and the depth of the re-cast layer appeared to be moderate. Again, no cracking was discovered.

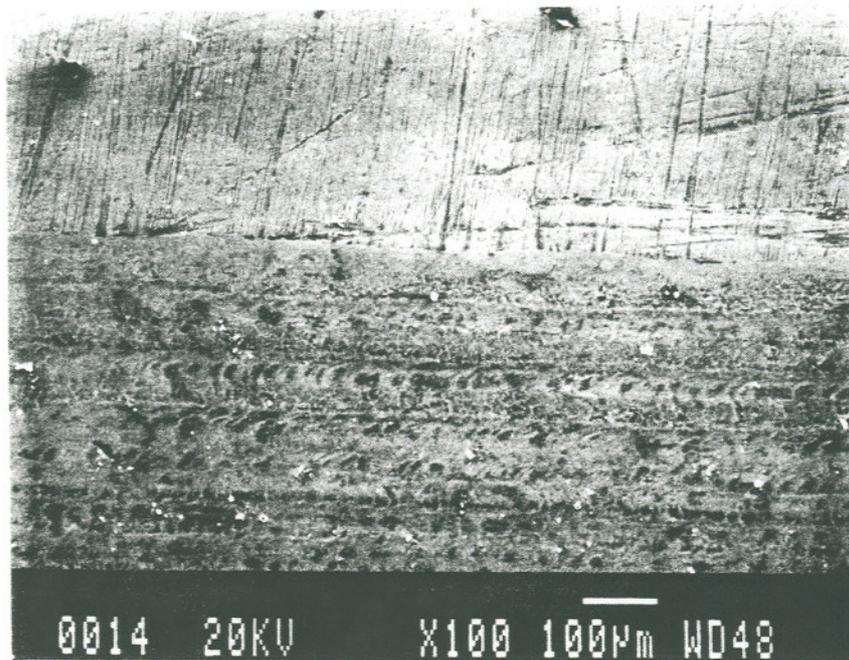
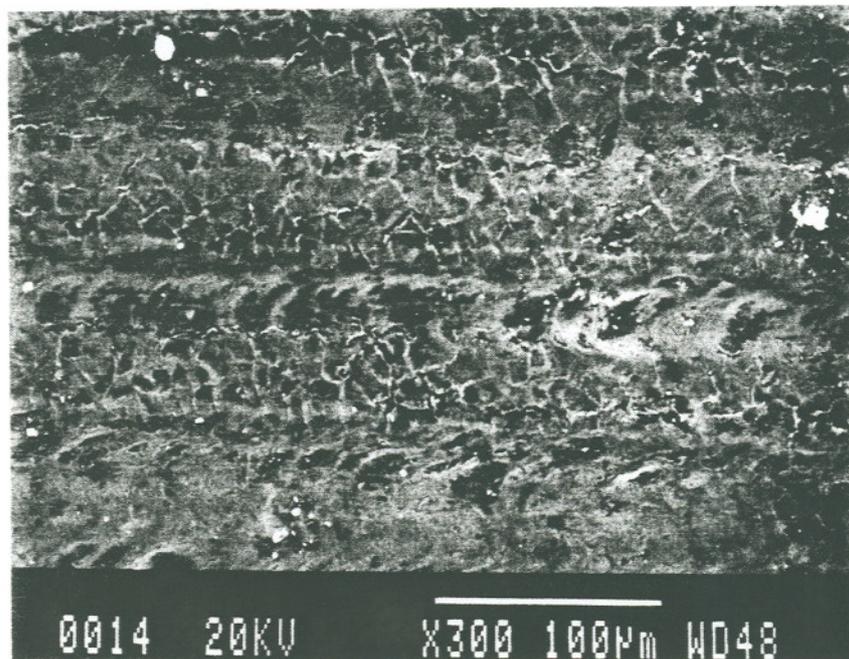
Figure 15. MP35N (100X & 300X)
This material marked well, exhibiting an apparent shallow re-cast layer with fine, but distinct surface texture. No cracking of the substrate was noted.

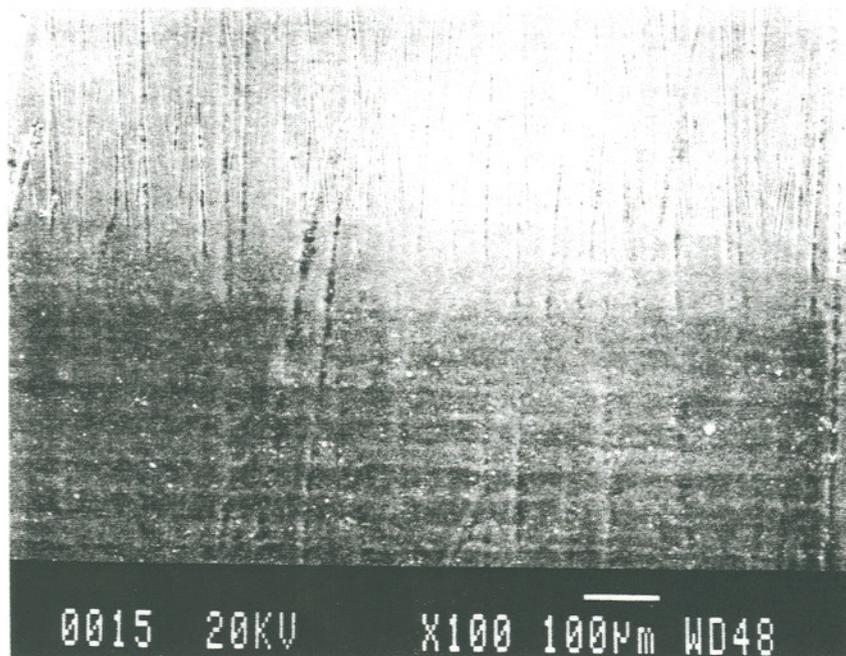
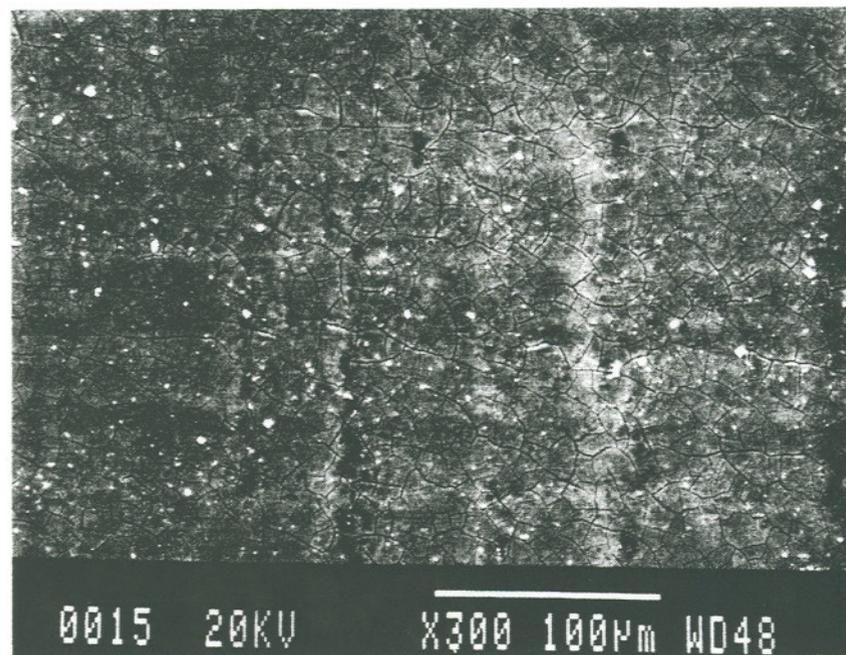
Both of the titanium materials exhibited a pattern of fine 'mud-flat' cracks on the laser marked surface. These cracks appeared to be generally superficial although no actual estimate of their depth could be made solely from SEM data. Refer to Figures 16 and 17.

Figure 16. *Ti-6Al-4V* (100X & 300X)
Re-casting of the surface layer resulted in smoothing of the surface texture. At higher magnifications surface 'mud-flat' type cracking was observed, but it appeared to be shallow.

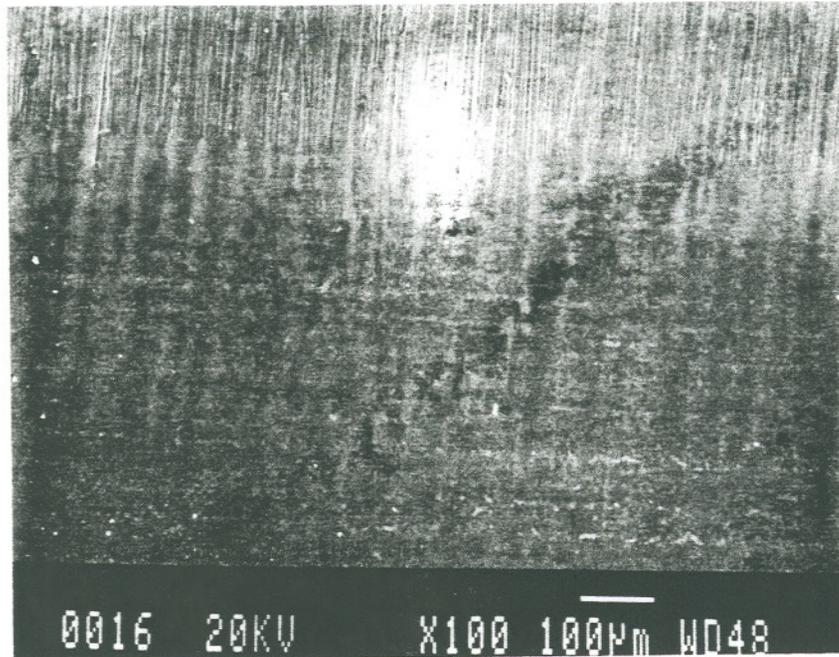
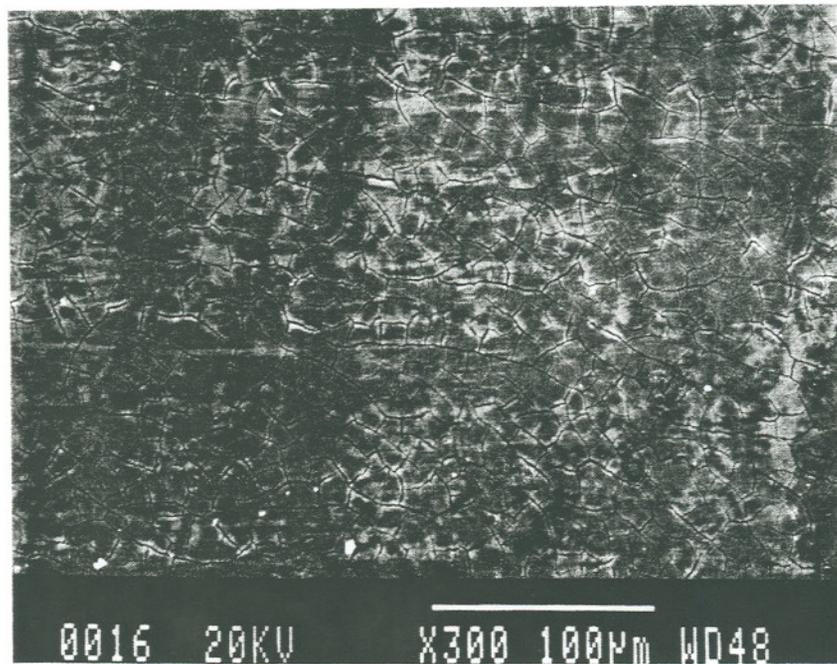
Figure 17. *Ti-3Al-2.5V* (100X & 300X)
Surface effects from laser marking were generally very similar to those found on the Ti-6Al-4V specimen.

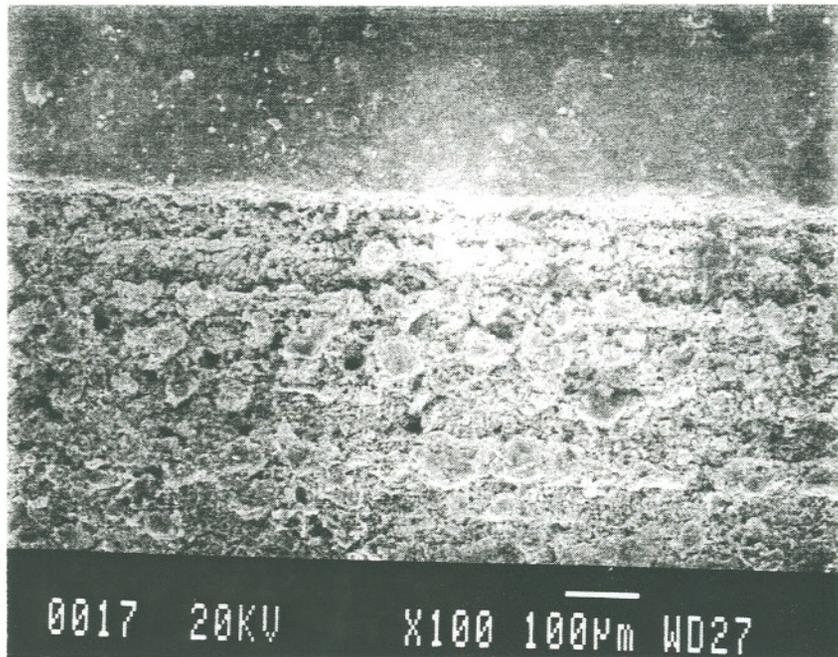
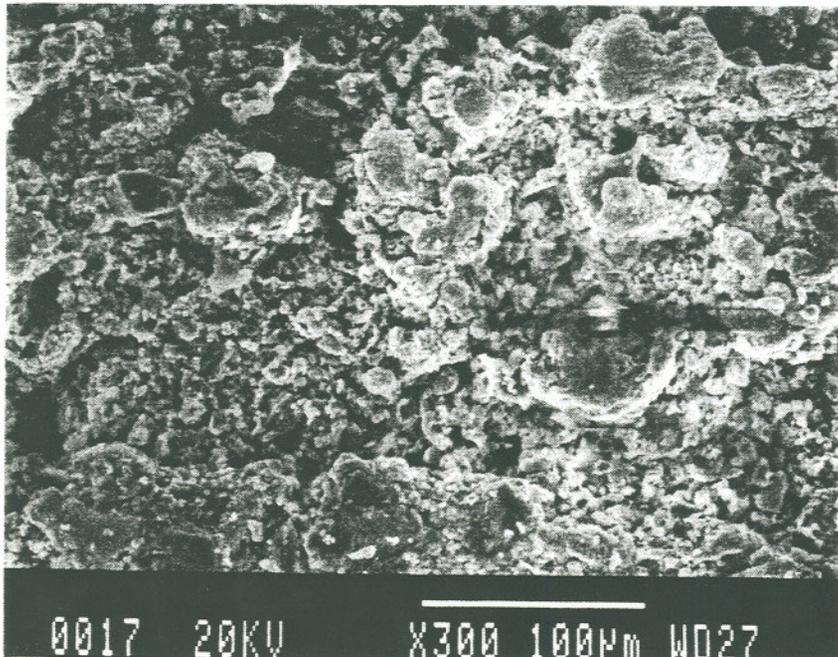
The Super Koropon painted aluminum specimen, Figure 18, exhibited a distinct delineation, with the laser marked area characterized by a very irregular texture. In this region the surface appeared broken up into a mixture of both larger and fine irregularly shaped particulates. No evidence of any cracking was discovered.

Figure 18. *Super Koropon over Aluminum* (100X & 300X) Surface texture in the marked area was very irregular, however no cracking was noted. While the aluminum substrate was not visible macroscopically, damage was present.

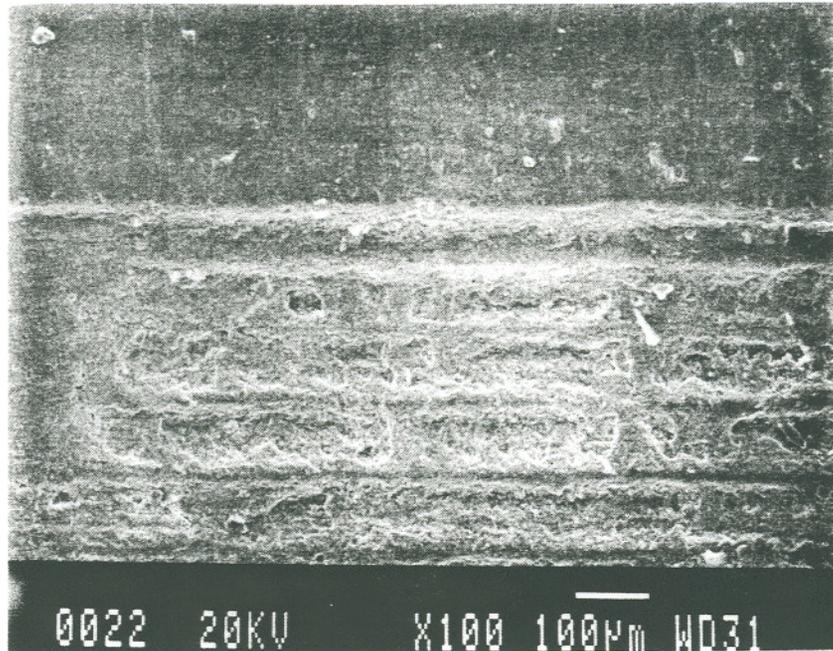
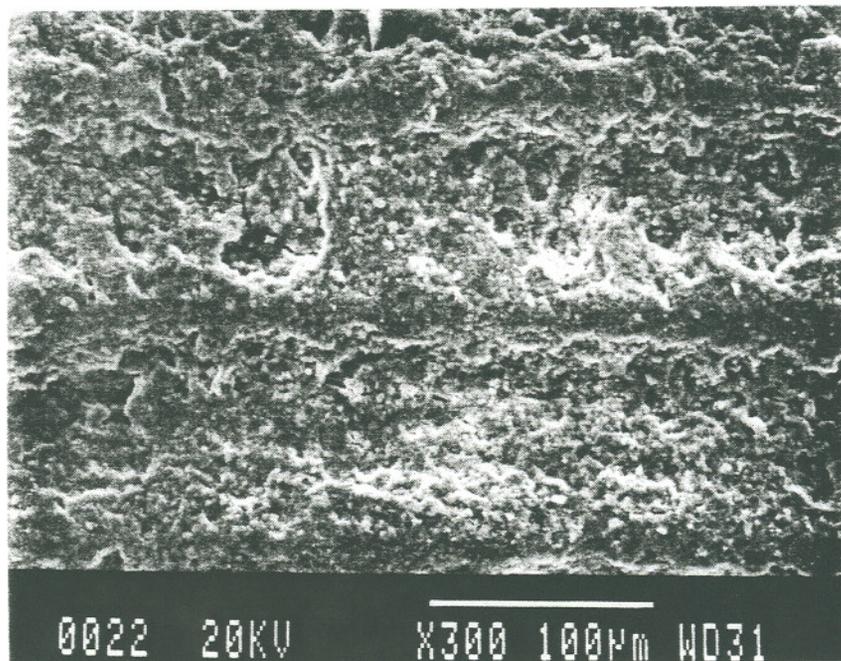
The neoprene rubber, Figure 19, was readily apparent as the laser marked region exhibited a roughened surface. The structure of the disrupted surface was generally fine, with no apparent cracking with a few longer troughs of greater damage located along the axis of laser travel.

Figure 19. *Neoprene Rubber* (100X & 300X)
The marked region exhibited fine surface roughness, but no evidence of any substrate cracking.

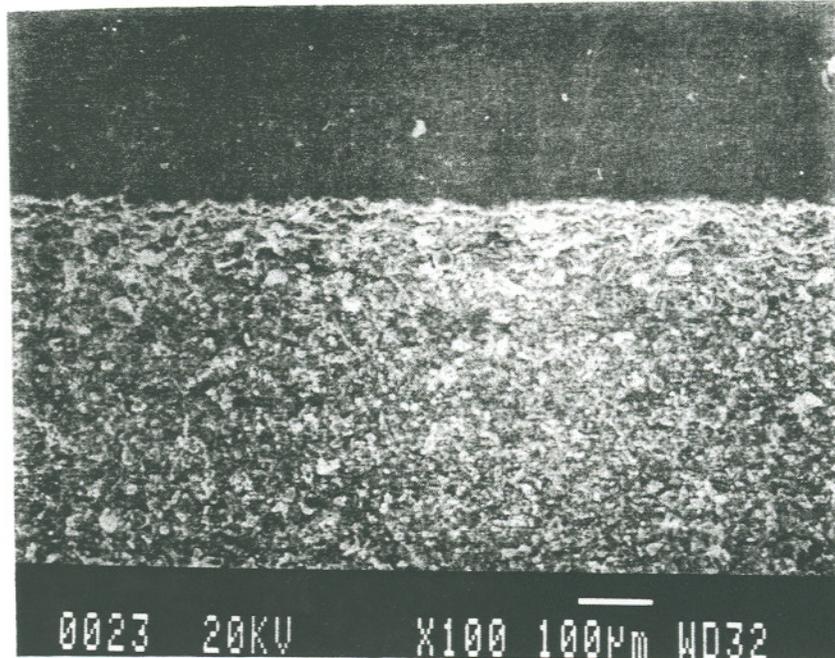
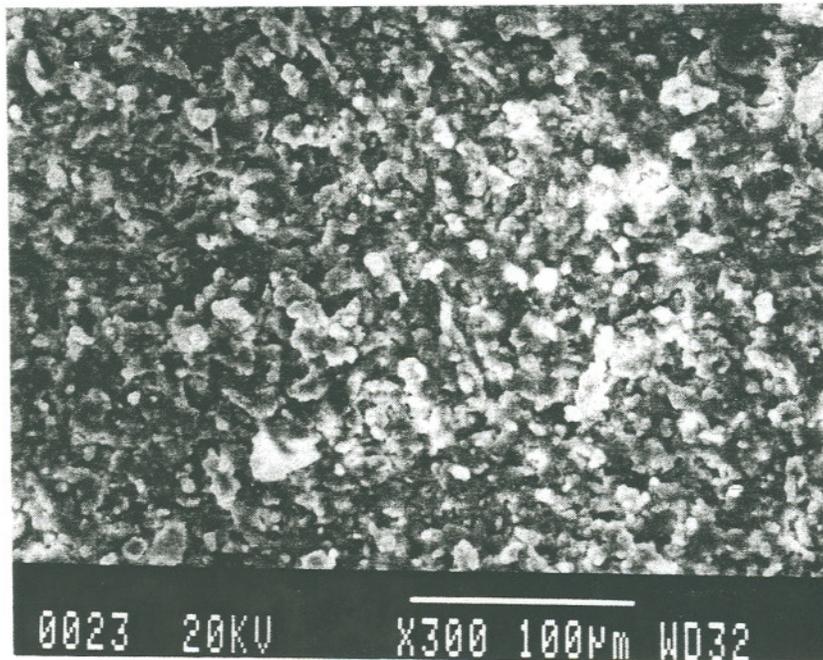
The silicone rubber specimen, Figure 20, exhibited the same general type of surface modification as the neoprene rubber, but was substantially more uniform in texture. No

Figure 20. *Silicone Rubber* (100X & 300X)
The marked area was uniform in texture, exhibiting moderate surface roughness. No indication of substrate cracking was discovered.

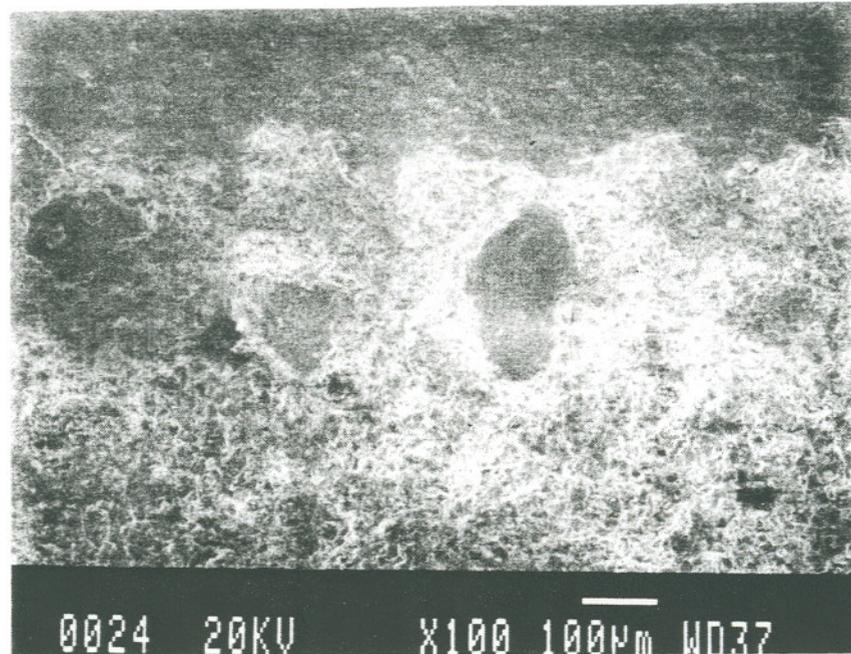
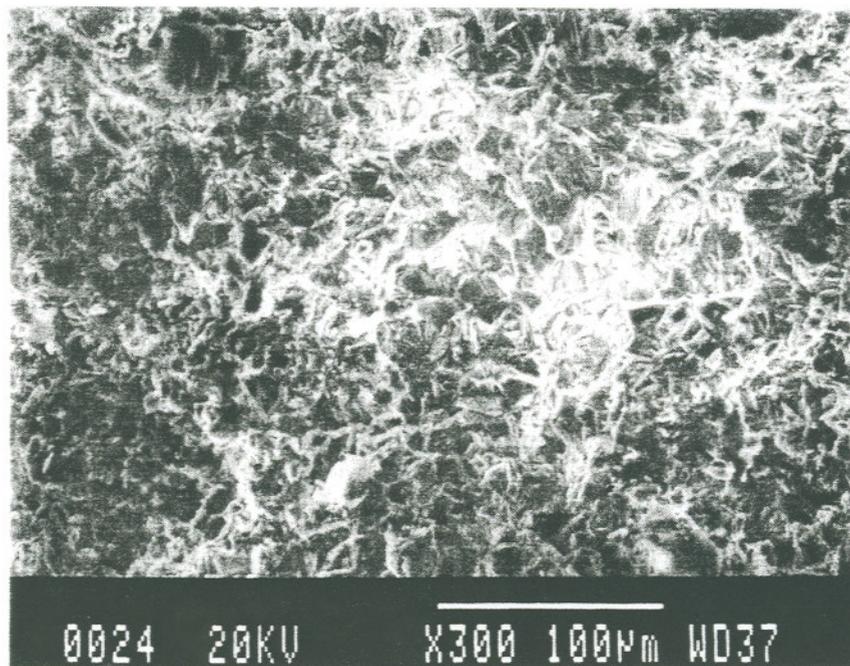
Lastly, the Macor specimen (which was not machine readable) was examined. As shown in Figure 21, the laser marked surface was substantially damaged, exhibiting sharp, although fine, surface roughness.

Figure 21. *Macor* (100X & 300X)
The marked region was readily distinguishable, however there appears to have been substantial substrate damage, mostly in the form of material erosion.
