LABORATORY TEST REPORT

LTR 6158-2470

EVALUATION OF VERICODE
LASER MARKED MATERIALS

Rockwell International
Space Systems Division

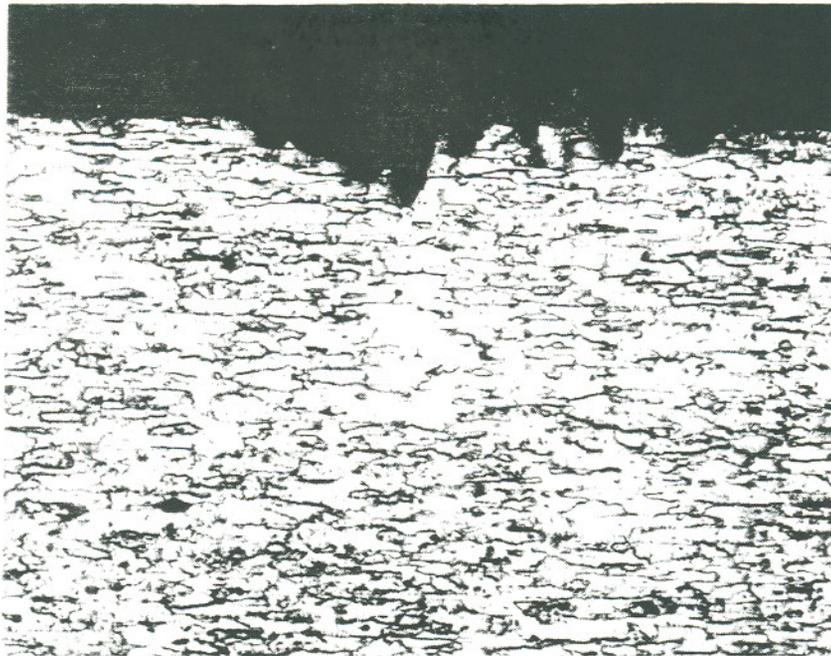
Figure 23. Metallography of 6061-T6 Aluminum showing moderate and irregular material erosion. Depth of penetration is about 0.001" (100X)

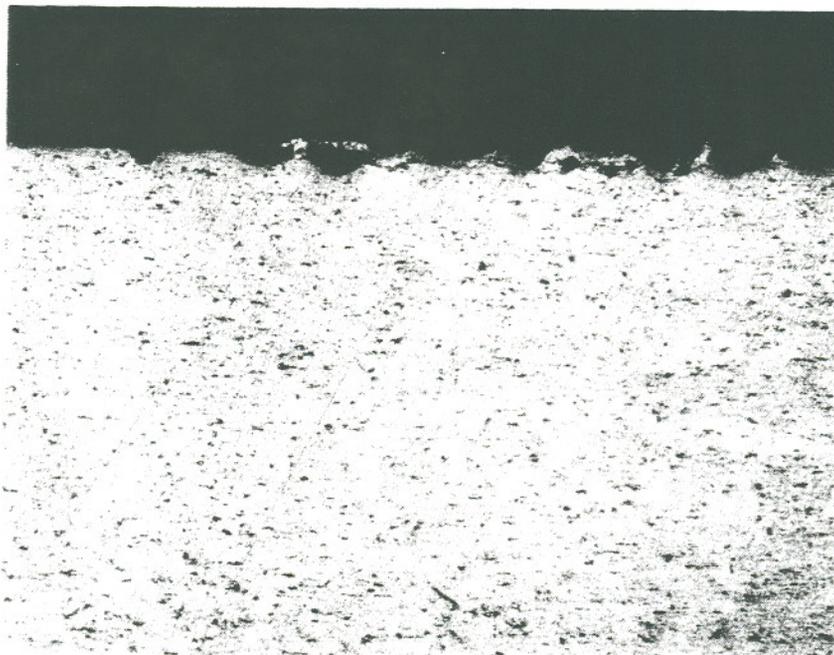
Figure 24. Metallography of 7075 Aluminum showing sharp, deep penetration (0.008") into the substrate. No cracking is apparent at any of the sites. (100X)

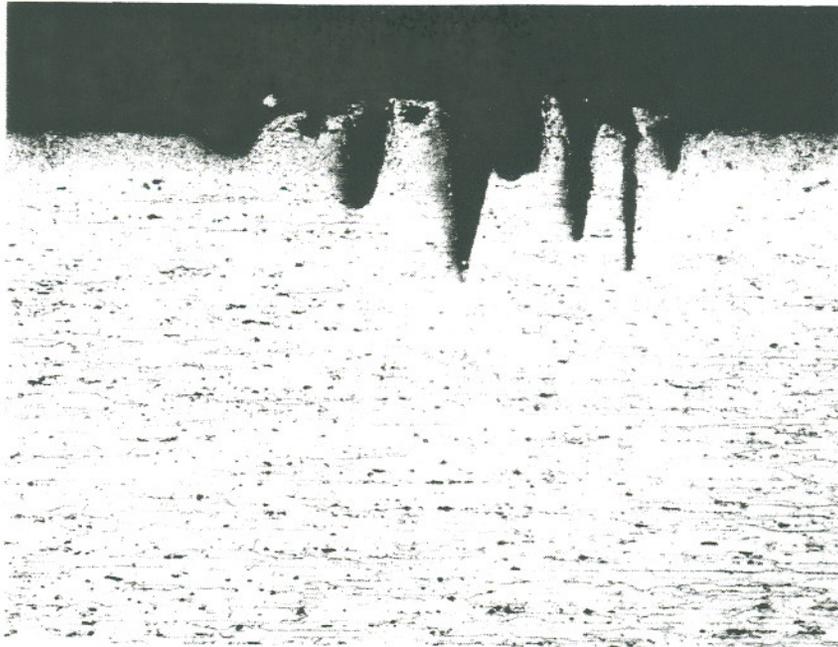
Figure 25. Metallography of 356.2 Aluminum showing irregular, smooth bottomed erosion of the substrate. No cracking is evident. (100X)

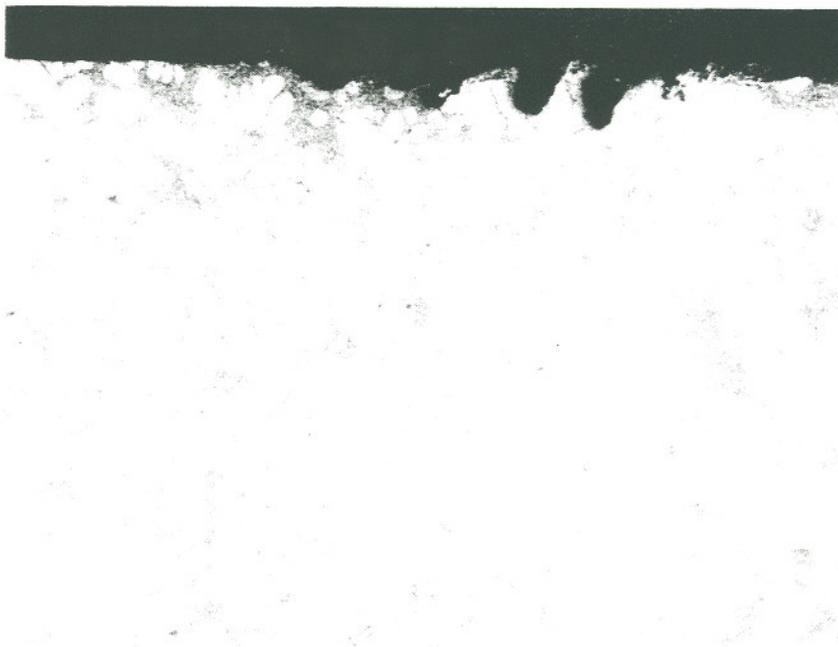
Figure 26. Metallography of CDA 101 Copper. The affected depth was less than 0.001" with no evidence of substrate cracking. (100X)

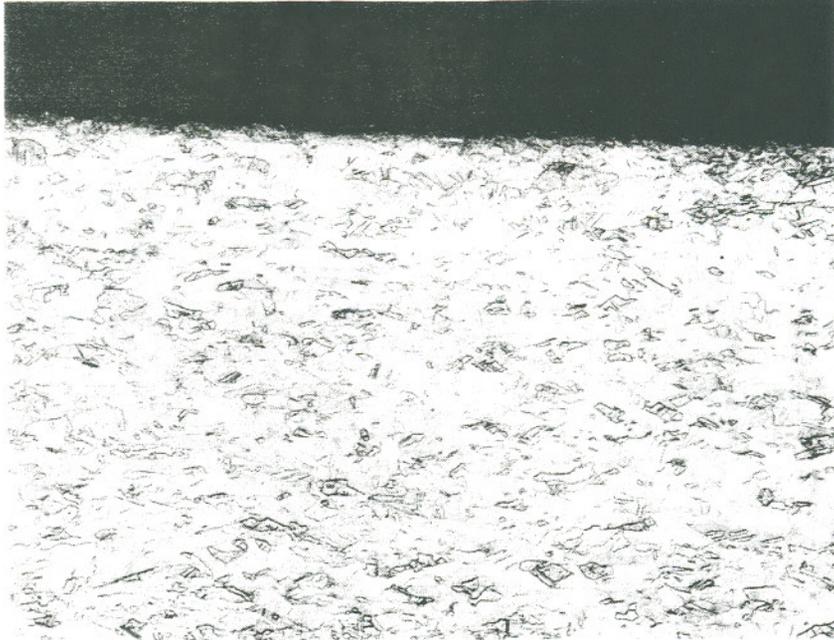
Figure 27. Metallography of C1020 Steel showing only minor surface roughness and an affected depth of less than 0.001". No cracking is evident. (100X)

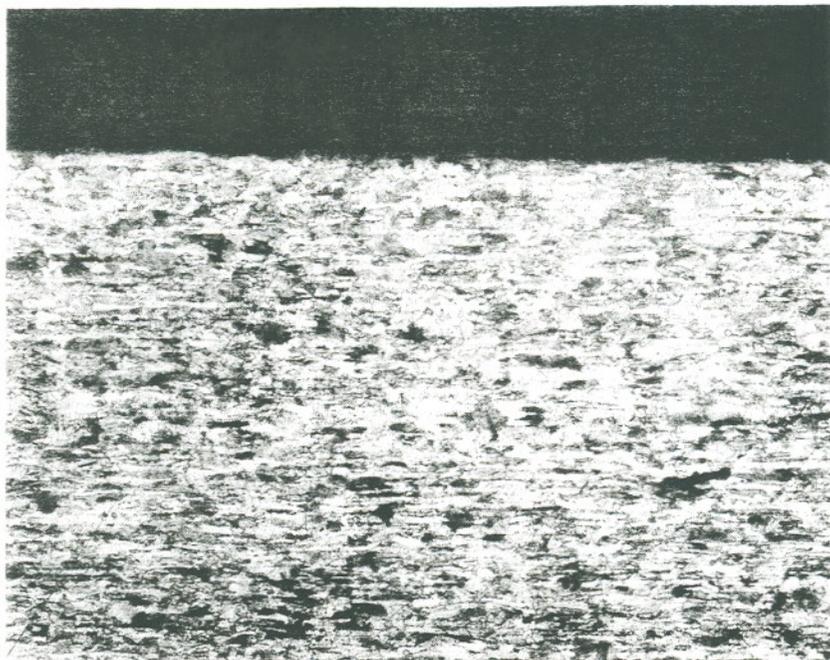
Figure 29. Metallography of 17-4PH Steel showing virtually no substrate damage. Only a slight surface irregularity is apparent. (100X)

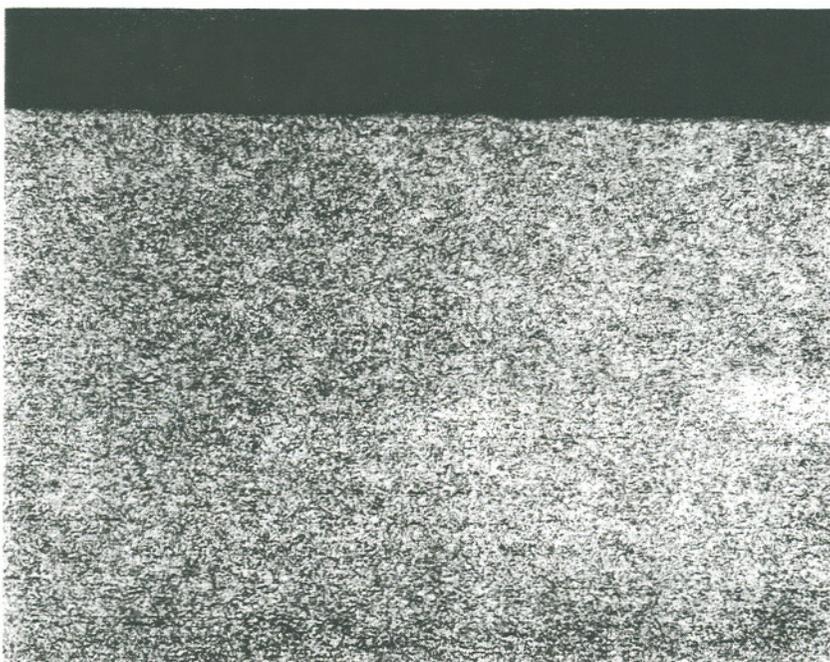
Figure 30. Metallography of 316 CRES showing slight surface irregularity to a depth of about 0.001". No cracking is evident. (100X)

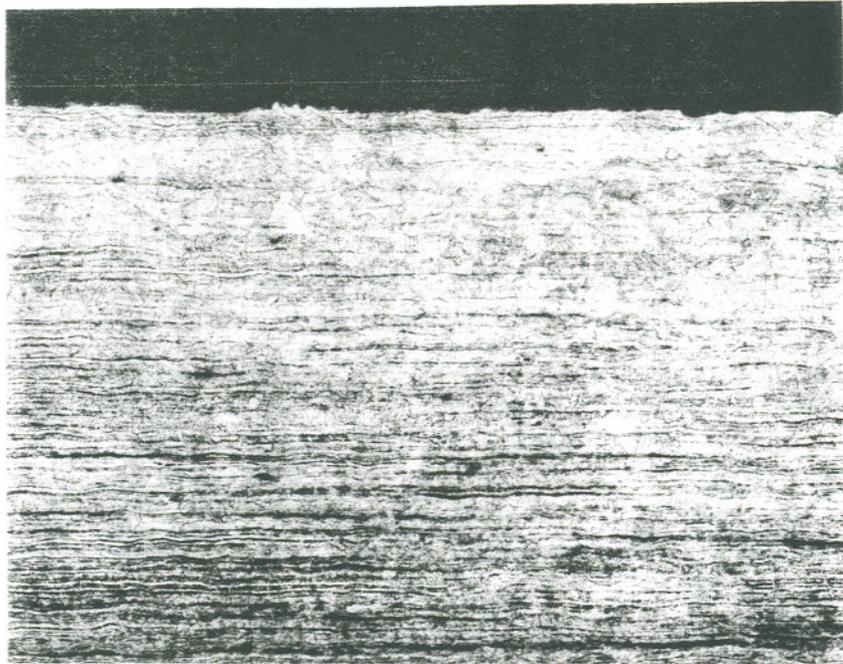
Figure 31. Metallography of 446 CRES showing shallow, rounded effect of laser marking. No substrate cracking was observed. (100X)

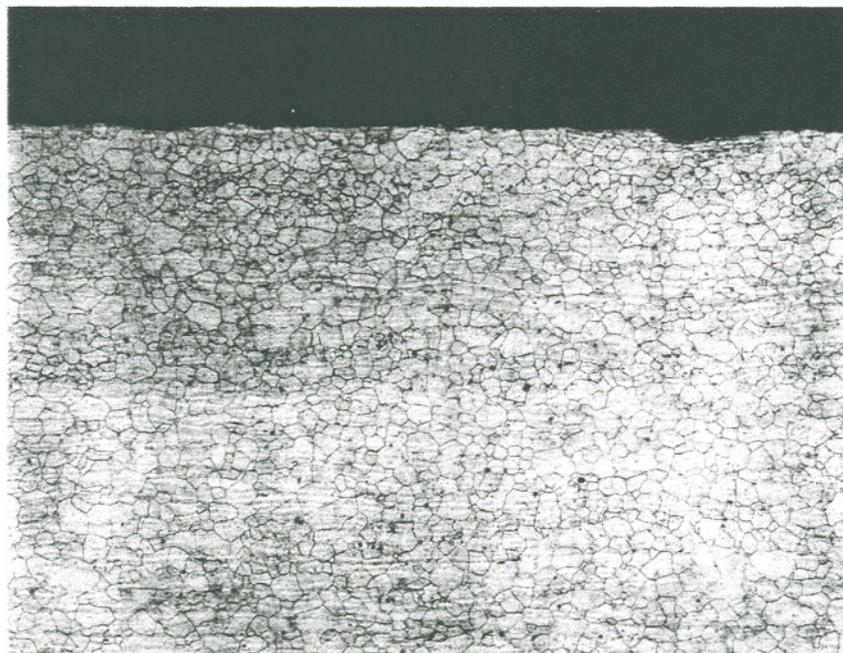
Figure 32. Metallography of A286 CRES. The material erosion was moderately deep (0.003") and irregularly shaped, however no substrate cracking was detected. (100X)

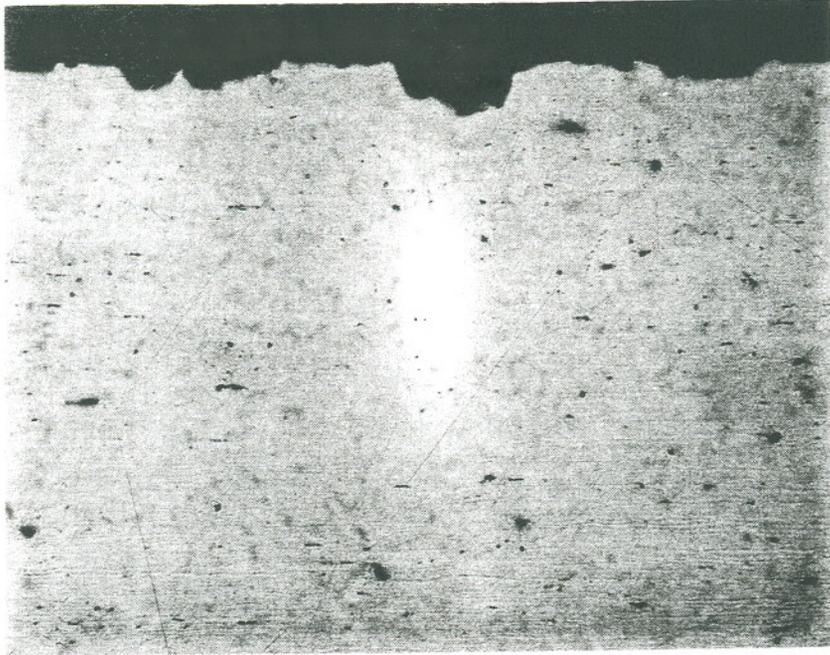
Figure 33. Metallography of Inconel 625 showing shallow, irregularly affected region. No substrate cracking is evident. (100X)

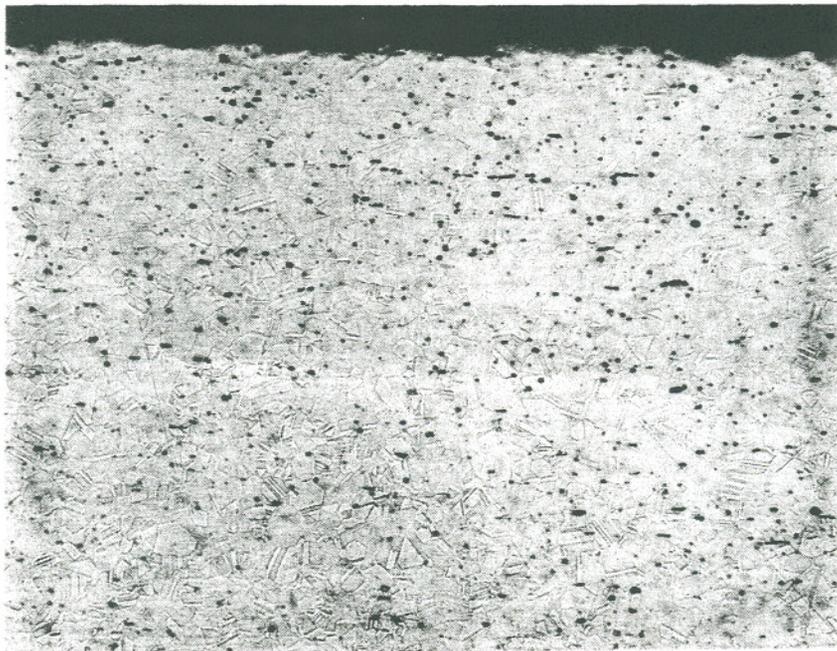
Figure 34. Metallography of Inconel 718 showing similar condition to that observed on the Inconel 625 specimen. (100X)

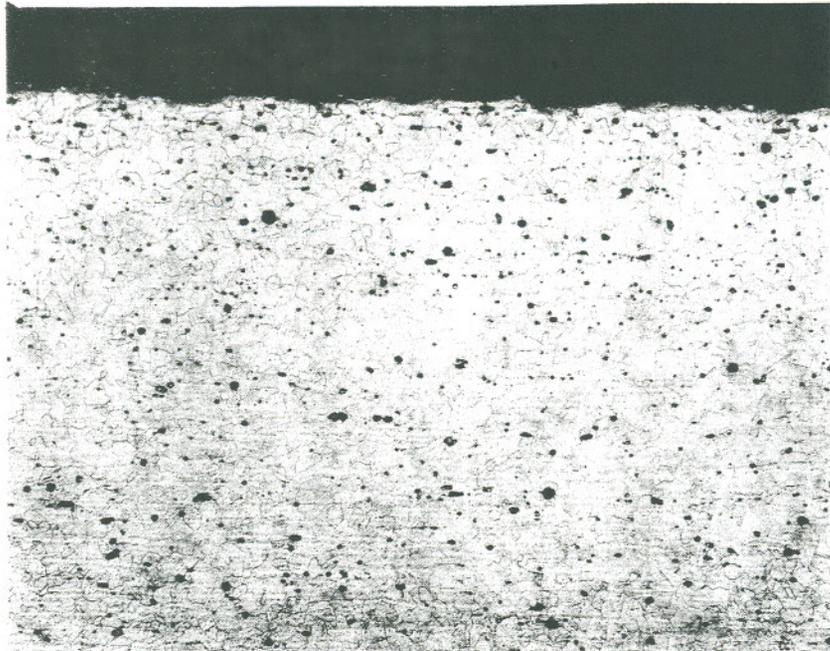
Figure 35. Metallography of MP35N. No substrate effect is apparent. (100X)

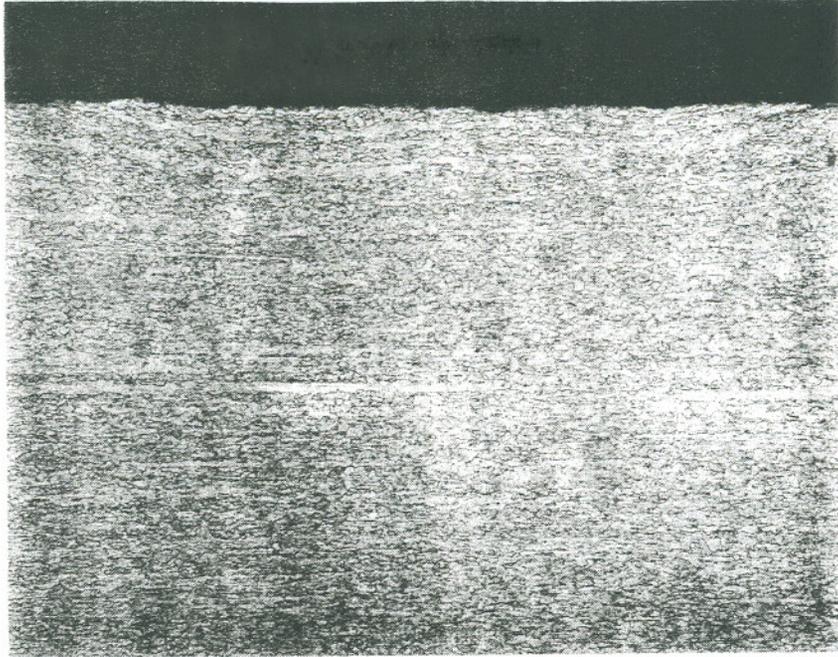
Figure 37. Metallography of Ti-3Al-2.5V showing conditions identical to that of the figure above. (100X)

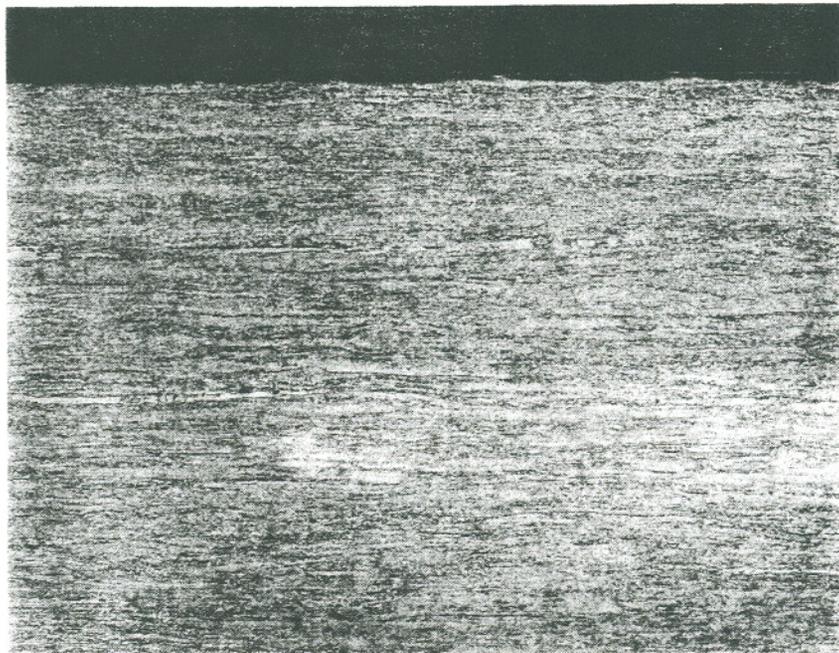
Figure 38. Metallography of Koropon painted aluminum showing damage to the substrate consistent with that observed on the other aluminum specimens. (100X)

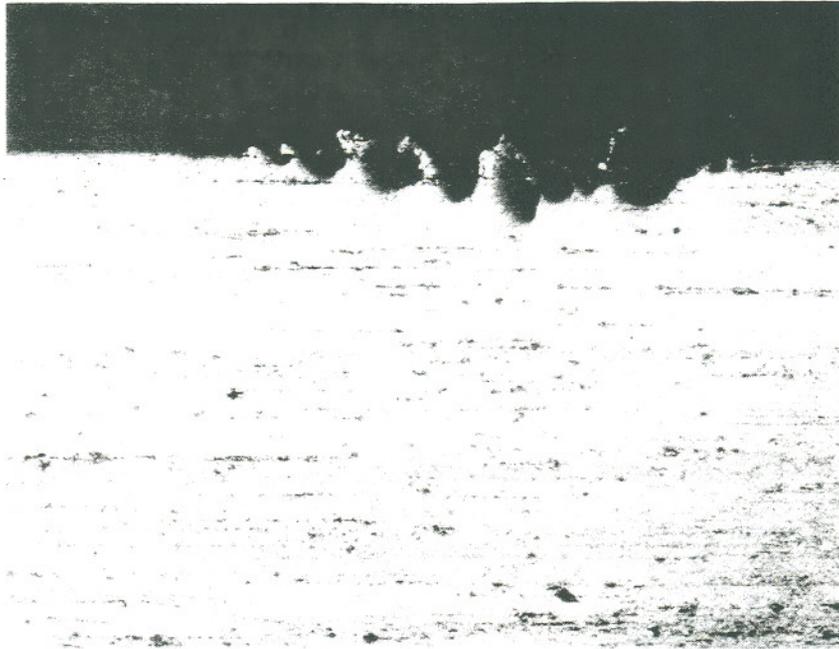
Figure 39. Metallography of Gr/Ep composite showing no visible effect of the laser marking on the substrate. (100X)

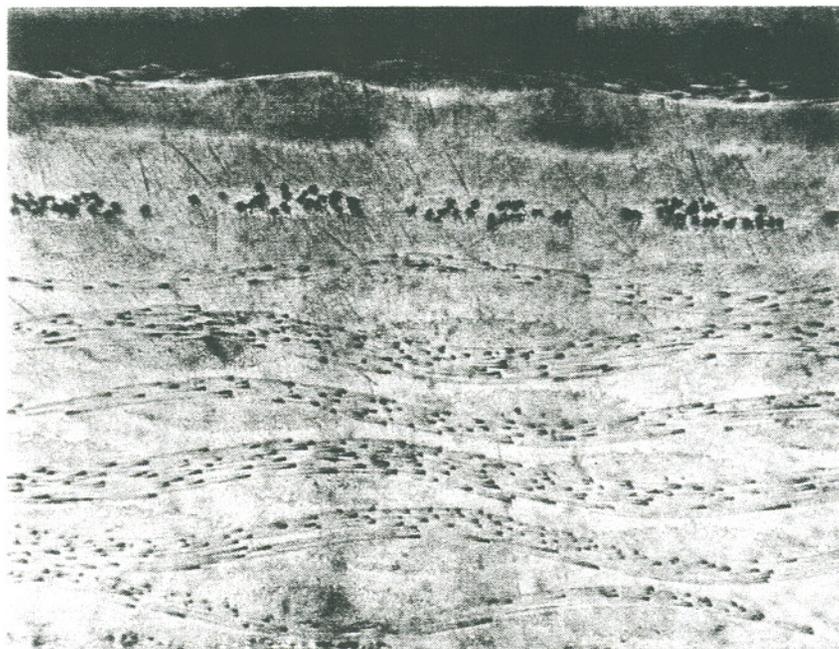
Figure 40. Metallography of Neoprene Rubber, showing the substrate to be smooth and rounded in the affected area. (100X)

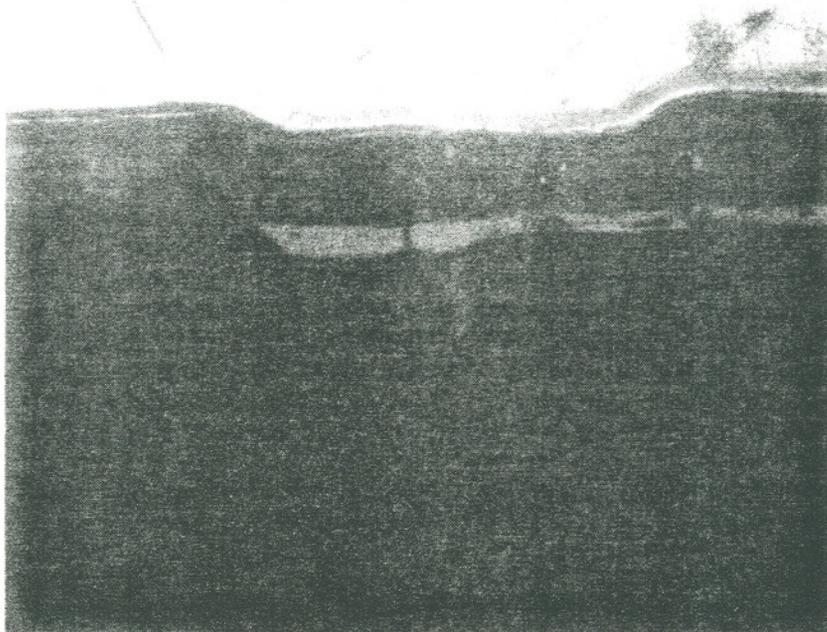
Figure 41. Metallography of Silicone Rubber, showing a smooth, rounded effect from laser marking. (100X)
