Small Arms UID

17 May 2006

William Boyle
US Army ARDEC
Picatinny Arsenal NJ

Pilot Project Test Summary

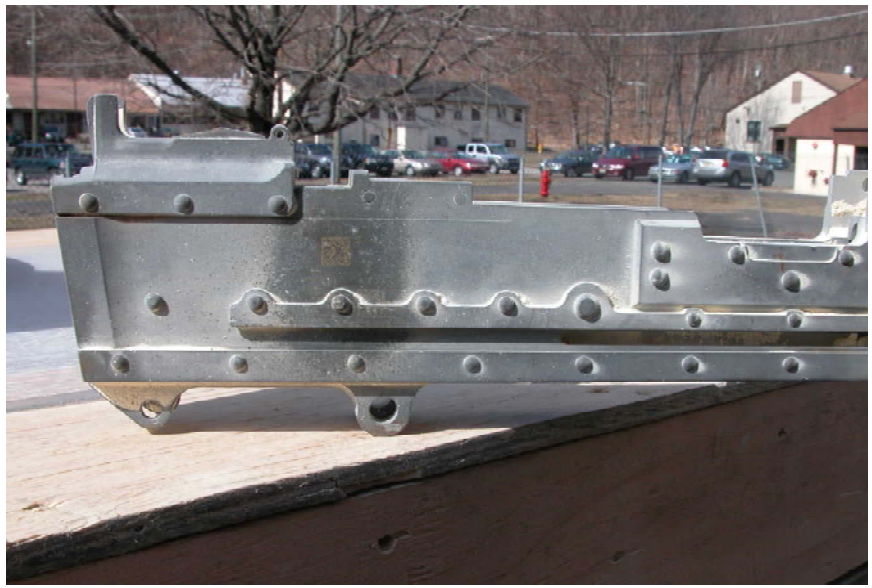
After Sand testing and before cleaning

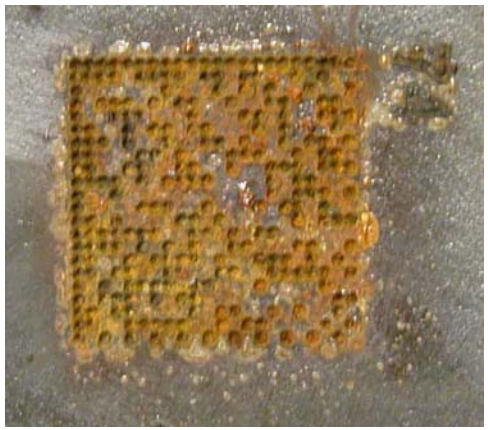
After Salt/Fog Testing (M240)

M240-74A deep laser,
Ahyde II w/clear coat

M240-41 laser etch
w/clear coat, Ahyde II

M240-49 laser etch
w/clear coat, Ahyde II

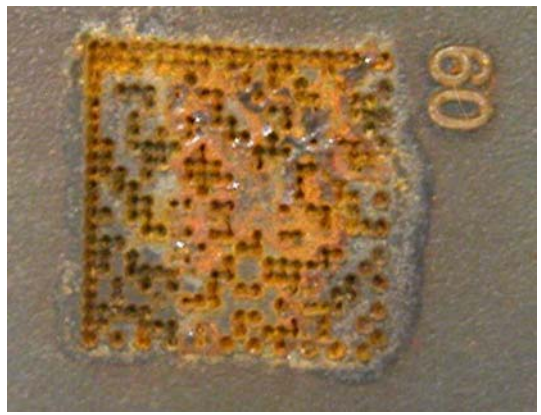
M240-60 deep laser w/clear coat (Krylon)

M240-2A DATALASE

Paint w/clear coat,
Ahyde II

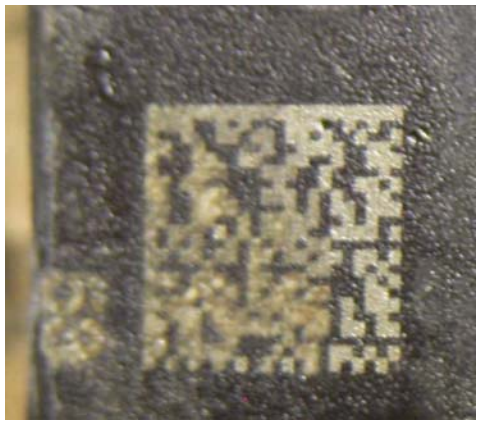
After Salt/Fog Testing (M9)

M9 9-53 laser etch w/clear coat, Aluma Hyde II

M9 9-38 laser etch w/o coating

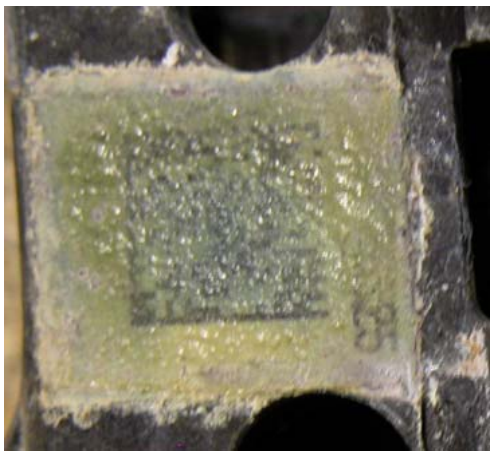
M9 9-25 Datalase paint, Aluma Hyde II w/clear coat

M9 9-45 laser etch w/clear coat (Evershield)

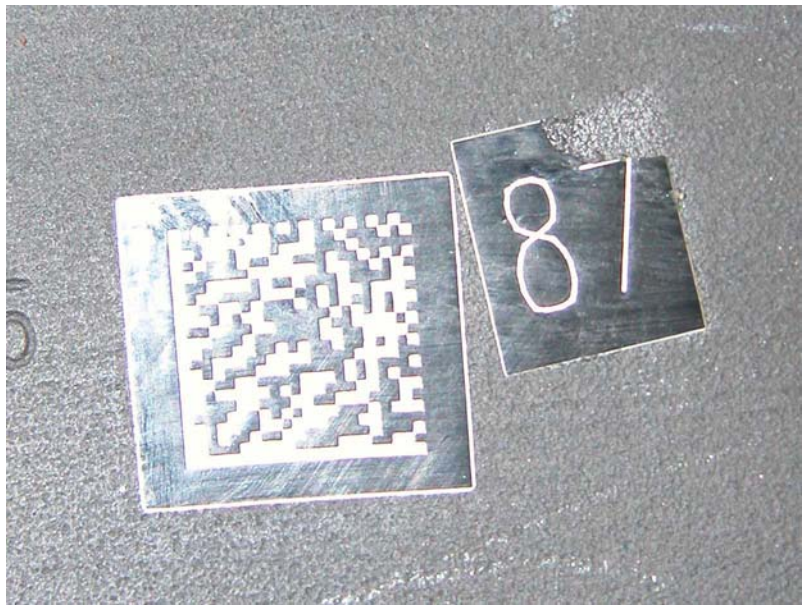
TESA Tape

- **Laser etching w/clear coat performed well but clear coat unable to survive Salt Fog Test**
  - Blistering was evident on two of the marks
  - One of the two was still readable
  - Multiple attempts were necessary to read the marks
- **TESA tape performed well but some durability concerns with cracking/peeling**
  - Some tearing on M9 pistol when placed too high on the back strap
  - Personnel were able to peel corner of the

- **Adhesive labels or name plates with a clear coat applied is recommended**
  - Clear coat prevents cracking or peeling and enhance durability of the tape
  - Use darker background (gray) rather than white 2D data matrix to reduce reflectivity
